SIB 32 01 23

2023-03-08

CRACKING/CREAKING NOISE FROM FRONT AXLE/STEERING SYSTEM

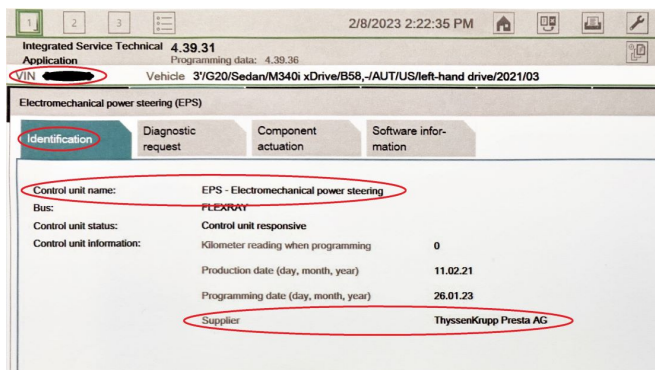
1. Verify a TKPS EPS is installed via ISTA control unit functions.
