SIB 32 04 20

## GROANING NOISE DURING HEIGHT ADJUSTMENT OF THE ELECTRIC STEERING COLUMN

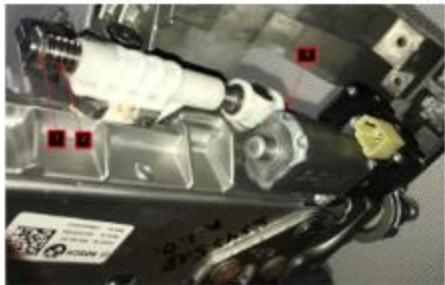
The spindle drive (2) is located on the right side of the steering column as viewed from the driver's seat.

The stop panel (1) of the spindle drive will need to be turned 90 degrees clockwise.

Before adjusting the stop spindle, the lock nut in the rear of the drive (3) must be secured in place.
