SIB 41 07 22

CRACKING SOUND FROM THE TOP OF B-PILLAR

E-Series	Model Description
G01	X3 Sports Activity Vehicle
G02	X4 Sports Activity Coupe

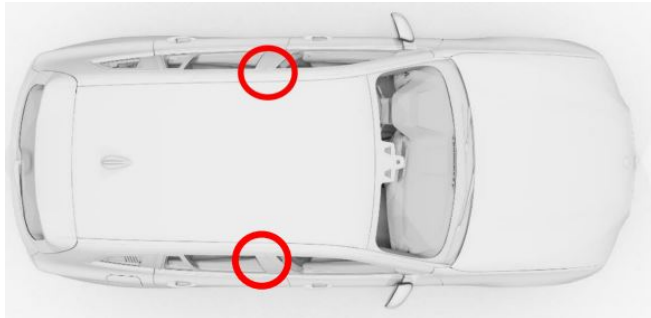
While driving the vehicle on normal roads at 10mph and above, a cracking sound from the top of the B-pillar(s) is heard.

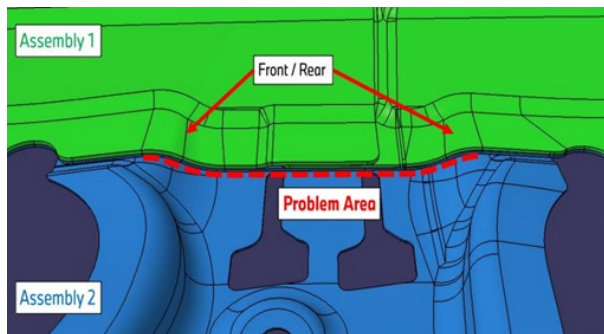
Movement of the sheet metal layers at the B-pillar(s).

Slightly bend the sheet metal layer at the top of the B-pillar.
