SIB 51 03 23

KNOCKING SOUND IN THE DASHBOARD/BULKHEAD AREA

E-Series	Model Description
F39	X2 Sports Activity Coupe
F48	X1 Sports Activity Vehicle

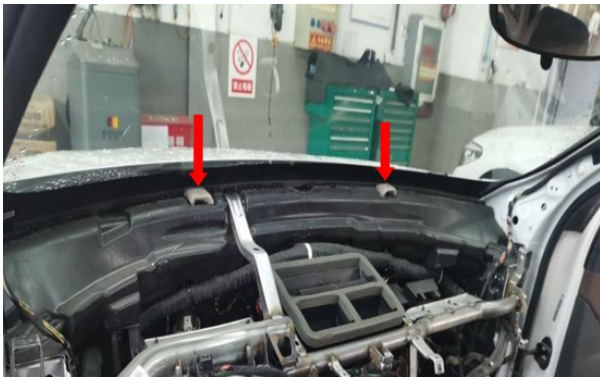
Unfavorable amount of felt adhesive bond at the connection point on the dashboard and bulkhead.

Apply felt strips to the contact surface area of both the dashboard and bulkhead.

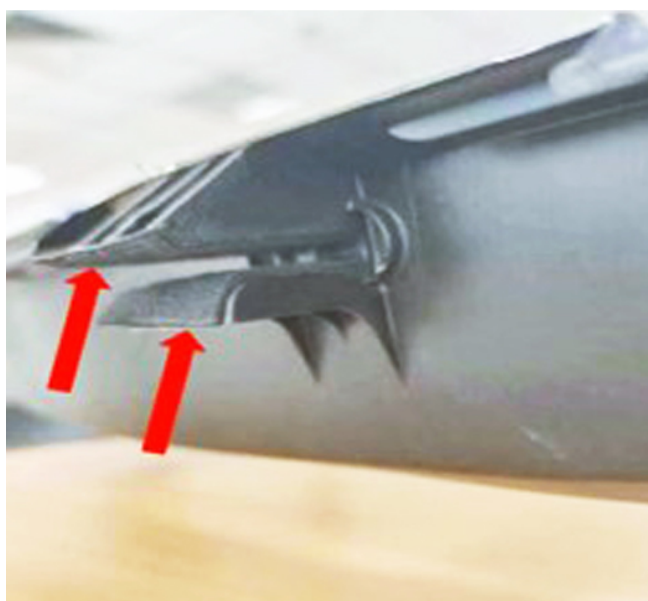
Location of both felt strips, on the upper and lower prongs of the dashboard retaining clips.
