## SIB 51 04 23

## 2023-03-24

# BLACK RESIN LEAKING FROM THE OUTSIDE DOOR HANDLE(S)

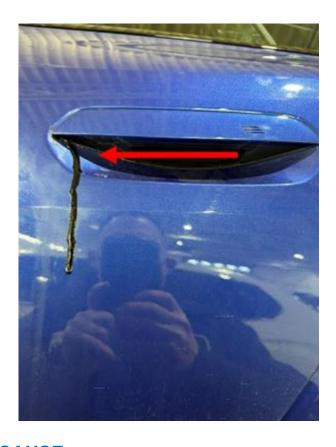
Black resin is leaking from below the outside door handle(s).

The resin has not fully cured properly on the handle and therefore can leak after installation.

Replace the affected outside door handle and clean the contamination on the door.

Replace the affected outside door handle following the repair instructions listed in AIR/ISTA (51 21 170).

If there are signs of the resin on the door paint, clean them off either with denatured alcohol, or the BMW cleaner R2 (P/N 83 19 0417324, 500 ml bottle).
