SIB 51 20 22 CRACKING SOUND IN THE HEADLINER AREA

2023-03-15

This Service Information Bulletin (Revision 2) replaces SI B51 20 22 **dated December 2022**.

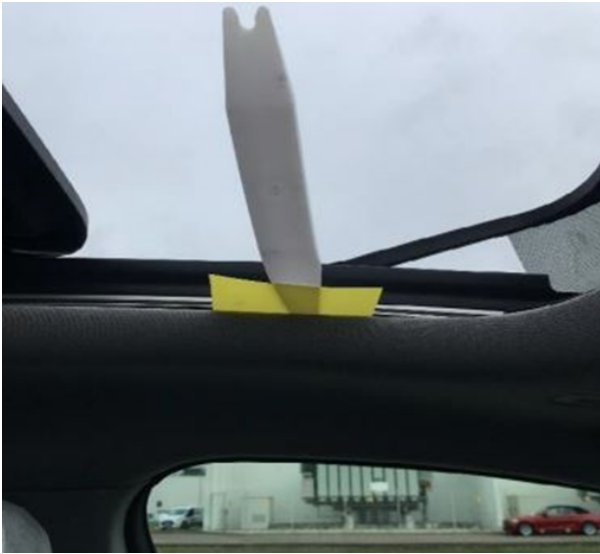
Cause 1:

1. The metal frame of the panorama roof cutout on the headliner is contacting the panorama roof.
2. Movement of the headliner holding clips.
3. The metal frame of the panorama roof cutout separates from the headliner.

1. Using a clip lifter, pry open the contact area to increase the gap to eliminate the contact. Make sure that the metal frame is not deformed in this visible area. If it is deformed, replacement is necessary (Reference the Cause 3 replacement repair instruction)

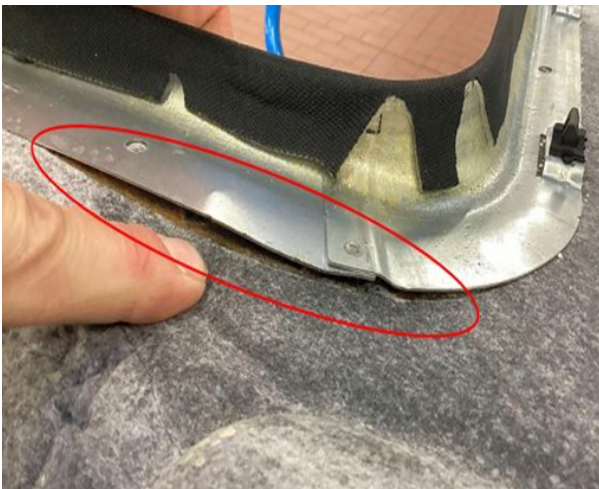
Cause 3:

1. After the headliner had been lowered, during (**Cause 2:**), it is discovered that the metal frame is visibly detaching from the headliner, the headliner must be replaced.

2. Replace headliner following the repair instructions listed in AIR/ISTA (51 44 011).
