SIB 61 03 23

2023-03-08

GEAR SELECTOR SWITCH (GWS) BUTTONS OR INDICATOR LIGHTING MALFUNCTION

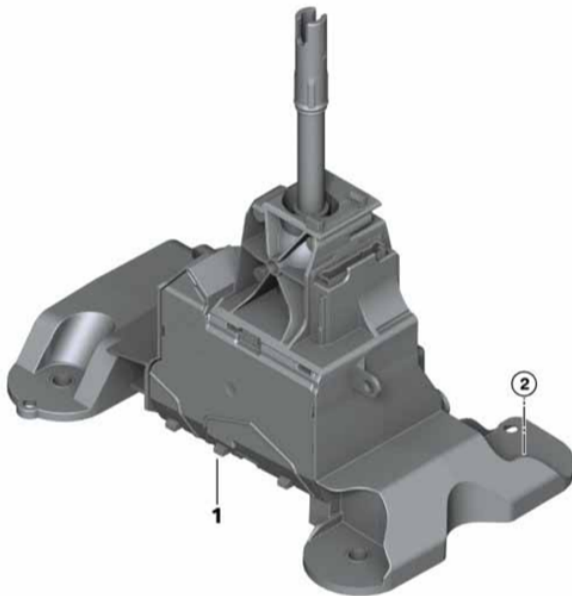
Damage to the shift box (Selector Lever) ribbon cable.

2. Replace the Shift box (Selector Lever), refer to repair instructions **25 11 007** “**Removing and installing gearshift bracket**”.
