SIB 61 06 23

DRIVER'S DOOR LOWER ARMREST IS NOT WARM

## MODEL

E-Series	Model Description	Affected Option Code
G70	7 Series Sedan	4HC Radiant Heating Package
I20	iX Sports Activity Vehicle, Battery Electric Vehicle

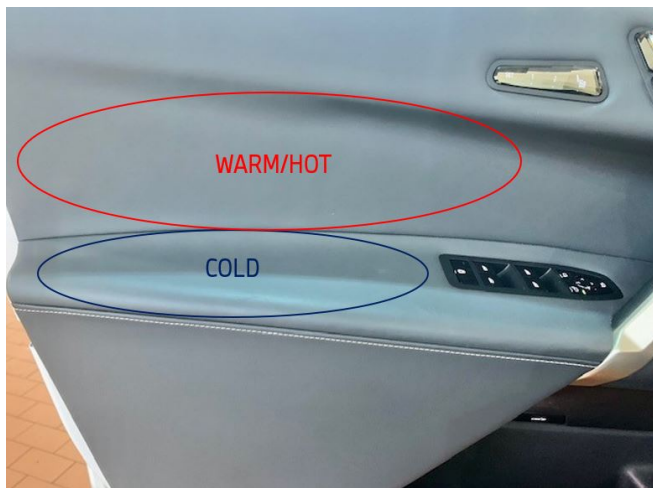
The lower armrest on the driver's door does not get warm.

Software error in the BCP (Basic Computing Platform).

Program the vehicle using ISTA version **4.42.1x** (estimated release date June 2023; pending verification).
