SIB 63 04 18

DAYTIME RUNNING LIGHT IS DIM OR DISCOLORED

This Service Information Bulletin (Revision 5) replaces SI B63 04 18 **dated June 2021**.

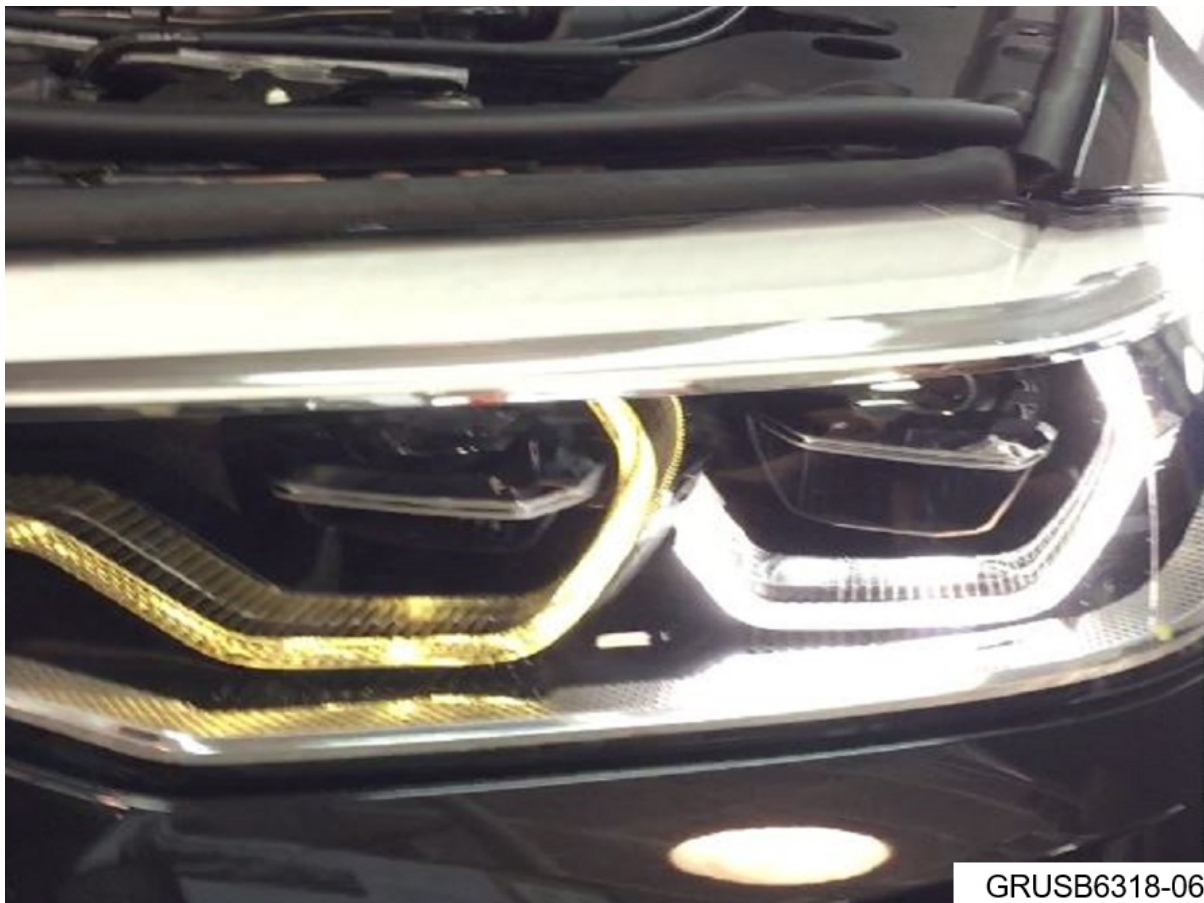
GRUSB6318-06

One or more of the LED daytime running lights are dim or discolored.

The connection between the LED module and light tube inside the headlight is damaged.

Inspect and replace the affected LED module. Replace the headlight only if internal damage is found to the light tube.

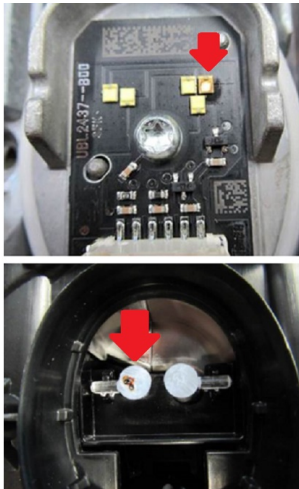
GRUSB6318-07

2. Inspect the LED module for signs of discoloration as seen to the left. If discoloration is present, inspect the light tube of the headlight for signs of discoloration.

Discoloration is present only on the LED module- Replace the affected LED module only, following ISTA/AIR repair instructions based on the vehicle model.

Discoloration is present on the LED module AND the light tube: Replace the complete headlight and the LED module, following ISTA/AIR repair instructions based on the vehicle model.
