Exhaust Drone at Takeoff or Under Light Acceleration

The information contained in this bulletin supersedes Service Bulletin No. L-SB-0003-18.

Some 2016 – 2022 model year RX 350 vehicles may exhibit a droning noise from the exhaust system at takeoff or under light acceleration. Countermeasure parts are available to reduce the droning noise. Follow the Repair Procedure in this bulletin to address this condition.

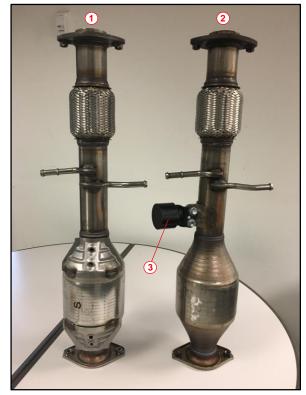
Figure 1.

Confirm if the vehicle has the NEW center exhaust pipe. The NEW part can be identified by the addition of a bracket and damper attached to the center exhaust pipe as shown.

1	Old Center Exhaust Pipe
2	New Center Exhaust Pipe
3	Bracket and Damper

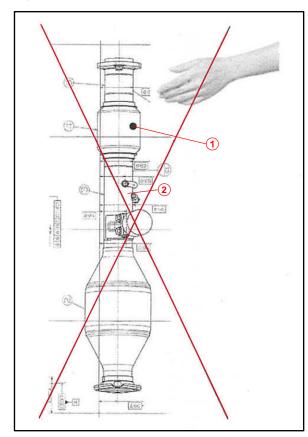
Figure 4.

The flexible joint of the center exhaust pipe assembly may become deformed if subjected to extreme force.

1	Flexible Joint
2	Do Not Bend

- Do NOT bend the flexible joint.
- Do NOT hold the center exhaust pipe assembly by the flexible joint end.
