# Rear Air Suspension Feels Rough Over Bumps

**Section** Suspension Control System **Market** USA and Mexico

Some 2023 model year Sequoia Hybrid and 2022 – 2023 model year Tundra and Tundra Hybrid vehicles equipped with air suspension may exhibit a rough-ride feel when driving over uneven road conditions such as bumps or dips. Follow the Repair Procedure in this bulletin to address this condition.

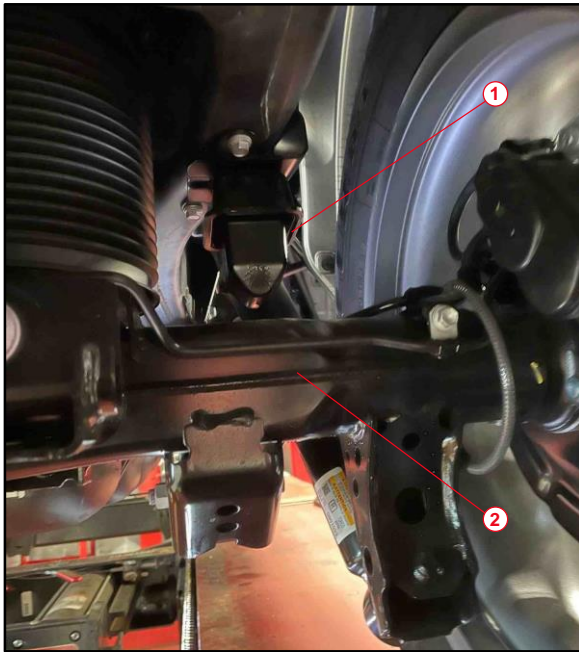
**Figure 3.**

- Under the vehicle, measure the distance between each rear bump stop and the top of the rear axle housing, as shown below.

<b>1</b>	<b>Bump Stop</b>
<b>2</b>	<b>Rear Axle Housing</b>

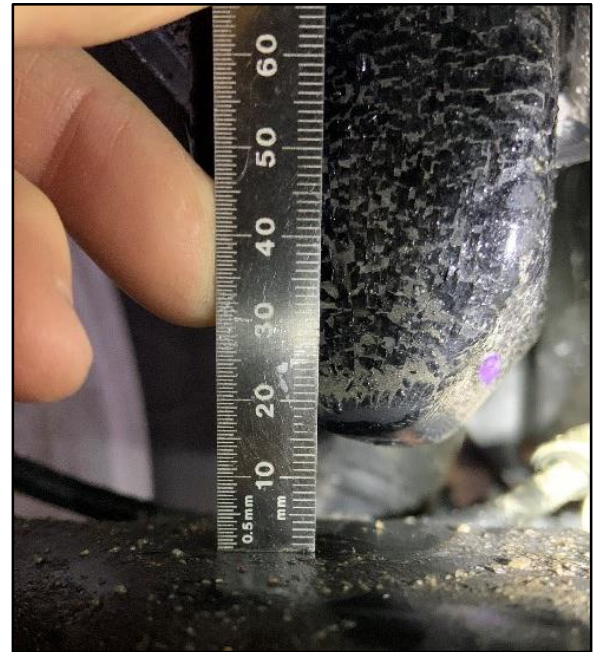
**Figure 4. Bump Stop to Rear Axle Housing Gap**

Is the gap less than 35 mm?

- YES** — Continue to step 6.
- NO** — This bulletin does NOT apply. Continue diagnosis using the applicable Repair Manual.

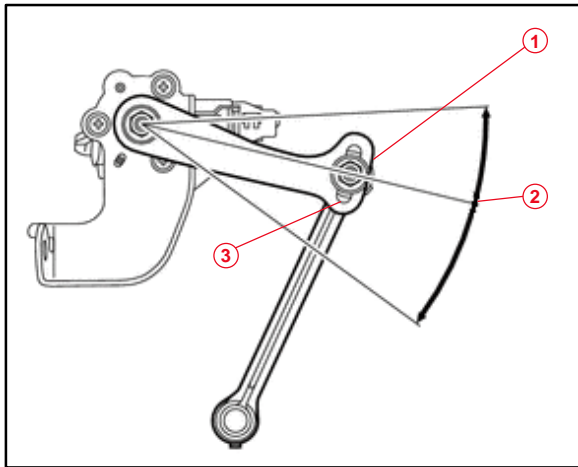
**Figure 5. Nominal Factory Setting Versus New Target Setting**

<b>1</b>	<b>Nut (Loosen)</b>
<b>2</b>	<b>Factory Setting for Nut Position</b>
<b>3</b>	<b>New Target Setting for Nut Position</b>

6. Adjust the height control sensor for each side.
  - A. Loosen the height control sensor nut.
  - B. Move the height control sensor link plate along the slotted hole of the bracket until it is positioned at the bottom of the slotted hole (see Figure 5).
  - C. Tighten and retorque the nut.

**Torque: 5.6 N\*m (57 kgf\*cm, 50 in\*lbf)**
  - D. Repeat on the opposite side.

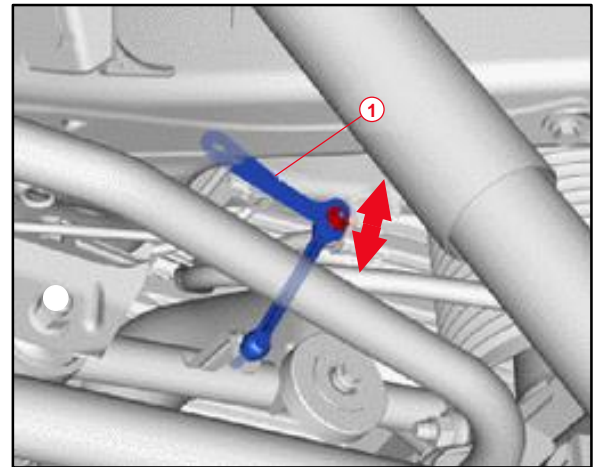
**Figure 6.**

<b>1</b>	<b>Height Control Sensor Link Plate</b>
----------	---

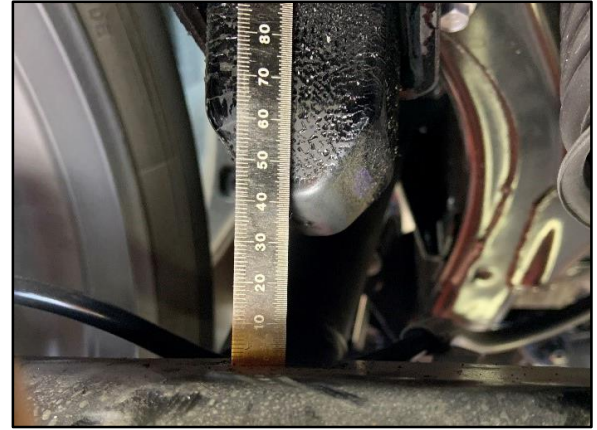
**Figure 7. Bump Stop to Rear Axle Housing Gap**

8. Measure the bump stop to axle housing.  
Is the gap measurement between 35 – 45 mm and equal side to side?
  - **YES** — Continue to step 9.
  - **NO** — Continue to adjust the height control sensors until an axle housing to bump stop gap of 35 – 45 mm is achieved. Then continue to step 9.

**NOTICE**  
Do NOT exceed 45 mm.
