Service Update

N232401090 Power Tonneau Cover Inoperative

Subject: N232401090 - Service Update
Power Tonneau Cover Inoperative

Models: 2022-2023 GMC HUMMER EV
Equipped with Accessory Power Tonneau Cover (RPO 5KM)

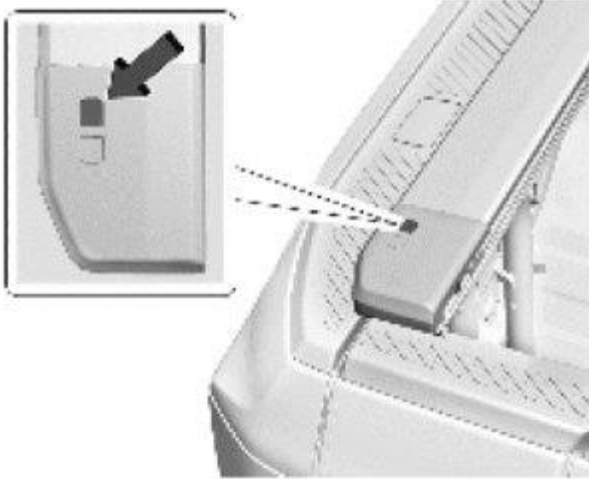
6325296

1. Open the tonneau cover to allow access to the Electronic Control Unit (ECU) located on the left side of the canister mounted near the front of the pickup box.

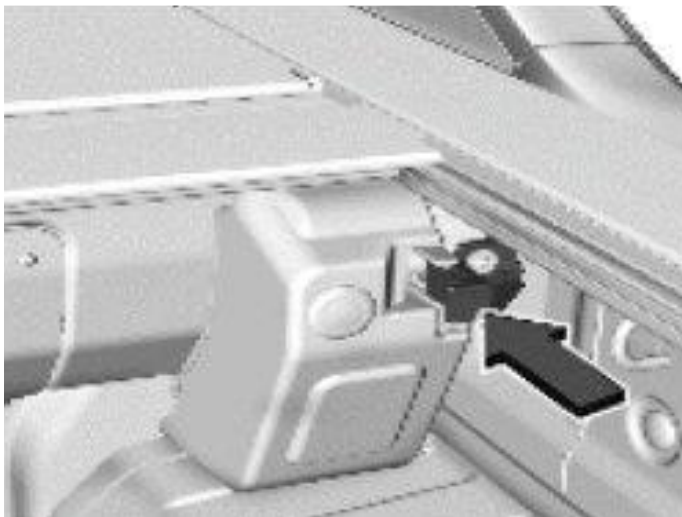
6325300

- Press the front button on the tonneau cover side rail to open the cover.

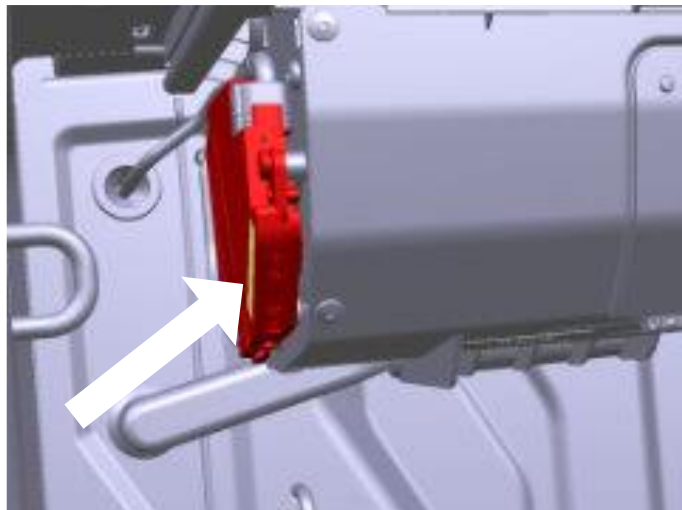
6325304

- If the power tonneau cover does not operate, **push** the motor clutch button located at right side of the canister to disengage the motor. Then push the cover slats forward.

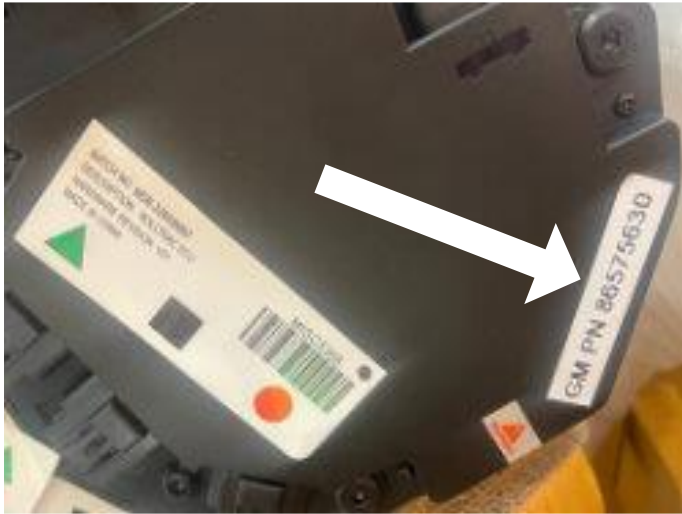
6325306

2. Inspect the Electronic Control Unit for a sticker containing the part number 86575630 as shown.
 - If the ECU has the part number sticker 86575630, no further action is required.
 - If the ECU does not have the part number sticker 86575630, proceed to step #3.
3. Remove the existing ECU and replace it with the new service part identified in the part table above.

TIP: The use of a mechanics mirror will aid in checking for the part number sticker.
