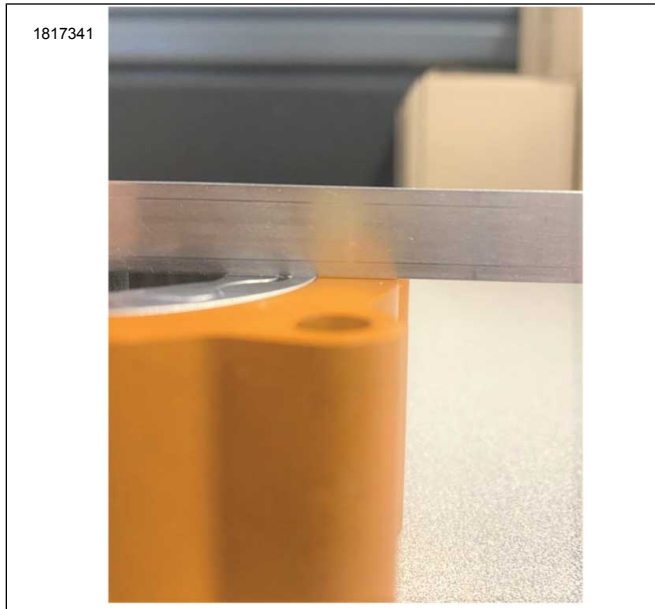
Figure 3. Straight End

5. See Figure 3. For oil pumps with manufacturing dates in February 2023, lay a straight edge across the gerotors and the oil pump face.
 - a. If the gerotor faces are projecting slightly higher from face of the oil pump, then the pump is defective.
