**PRODUCT CAMPAIGN BULLETIN**

<p><b>APPLICABILITY:</b> 2003-14 MY Legacy          2003-14 MY Outback          2003-06 MY Baja          2009-13 MY Forester          2004-11 MY Impreza          2004-14 MY WRX and STI</p> <p><b>SUBJECT:</b> Takata Front Passenger Airbag Module / Inflator “Like for Like” Recall</p>	<p><b>NUMBERS:</b> TKA-20R          TKB-20R          TKC-20R</p> <p><b>DATE:</b> 01/06/20</p> <p><b>REVISED:</b> 04/04/23</p> <p><b>NHTSA ID:</b> 20V001          20V002          20V003</p>
--	--

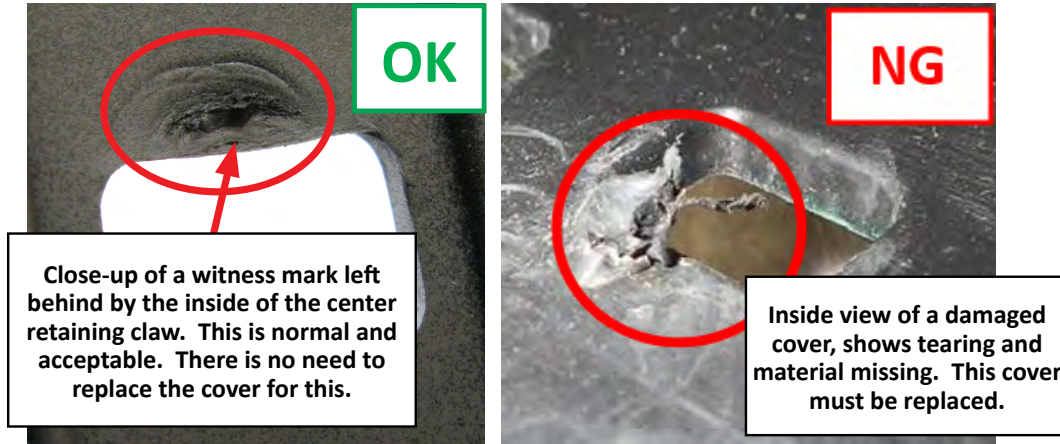
- Inspect the claw openings on the outside and inside of the cover for damage. If any found to look like the NG example photo below, the cover must be replaced.
