SERVICE BULLETIN

APPLICABILITY: 2019-**23**MY Ascent
SUBJECT: Hood Panel Vibration

NUMBER: **12-281-20R**

REVISED: **04/05/23**

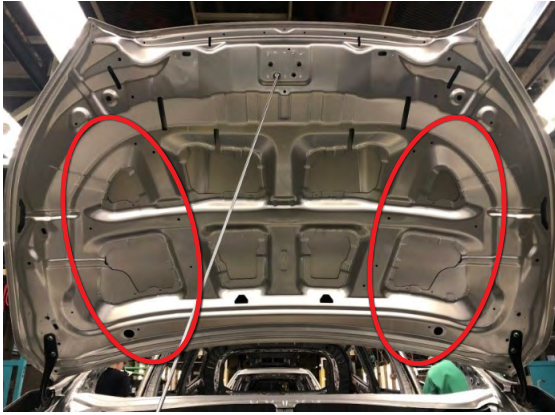
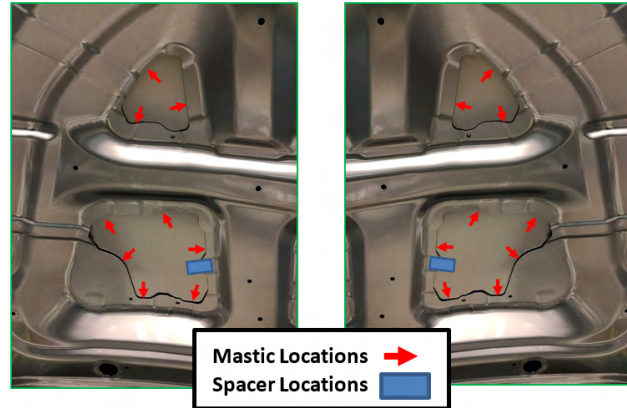
- Use the photos below to identify the inspection areas and determine the potential repair points.

- Before applying adhesive, CAREFULLY insert the spacer between the inner and outer hood panels at the location (s) indicated in the above photo on the side intended for the repair. Use two spacers if both the left and right side need to be repaired. Keep the edge of the spacer outside the gap as shown to make removal after the adhesive is cured easier.

- Using the fine point tip of the applicator nozzle, CAREFULLY apply the adhesive between the outer and inner hood panels as indicated in the photo above. Apply enough material to adhere both panels, keeping the width of the adhesive approximately 18mm (3/4in.).

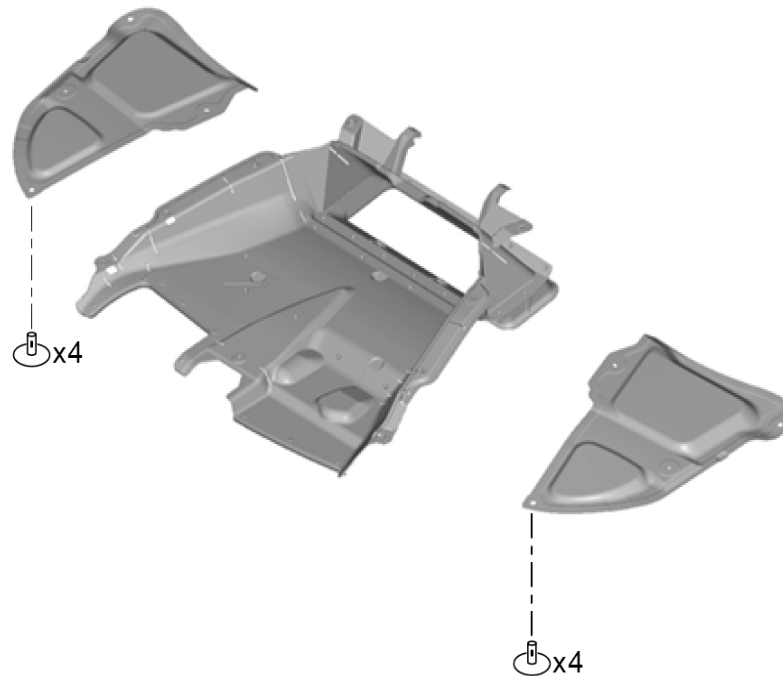
CAREFULLY remove the under hood insulation materials following the procedure in the applicable Service Manual. **NOTE:** The four (4) retaining clips (qty. 8 total) for both outer sections shown below p.n. **90814FC001** are 1-time use and **MUST** be replaced at reassembly.

- Thoroughly clean all areas indicated in the photos above where the repair adhesive will be applied with alcohol wipes (or isopropyl alcohol on a **clean** shop cloth). All application areas must be completely free of any foreign material (grease, dirt) which could prevent proper adhesion to either panel. Always allow the alcohol to dry completely before proceeding with application of the adhesive.
