**SERVICE BULLETIN**

**APPLICABILITY:** 2018-23MY Legacy and Outback  
 2017-23MY Impreza  
 2018-23MY Crosstrek  
 2019-23MY Forester  
 2019-23MY Ascent

**NUMBER:** 16-132-20R

**SUBJECT:** Diagnostic Information for Alleged Chain Slip Condition on TR580 / TR690 Transmissions

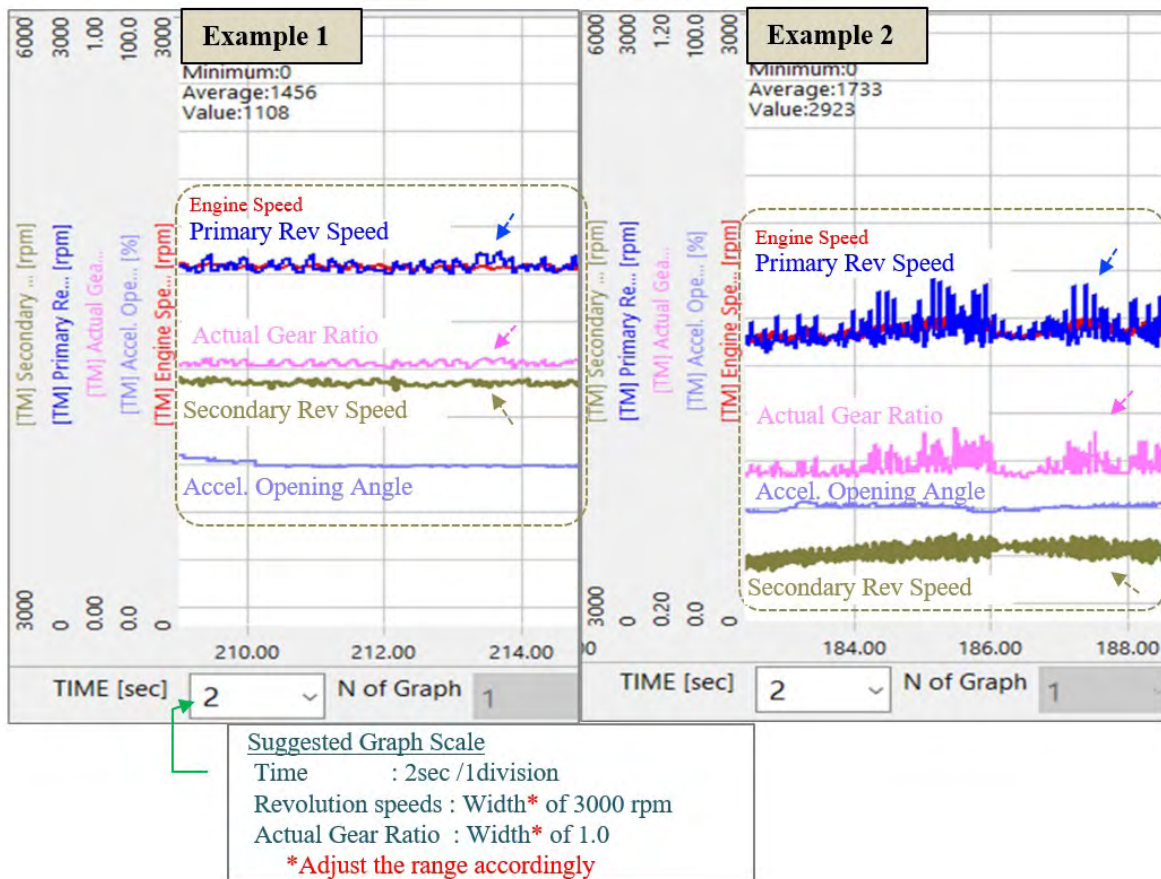
#### 1. Continuous Micro-Slip:

During a continuous micro-slip, while the Accelerator Opening Angle monitor displays a stable value for more than one second, there are fluctuations in the Actual Gear Ratio monitor:

**Peak to Peak > 0.02**

**Frequency > 3 cycles per 1 second**

There are fluctuations in the Primary Rev Speed and/or Secondary Rev Speed monitor:

**Peak to Peak > 50 rpm**

Below are two examples of the data monitoring during Continuous Micro-Slip

Using Subaru Select Monitor (SSM), check and record data monitors and compare to the three examples listed below. If the recorded data from the vehicle matches the examples below, the CVT will require replacement. The SSM data will be required for claim submission. A QMR containing the same information will also be required.

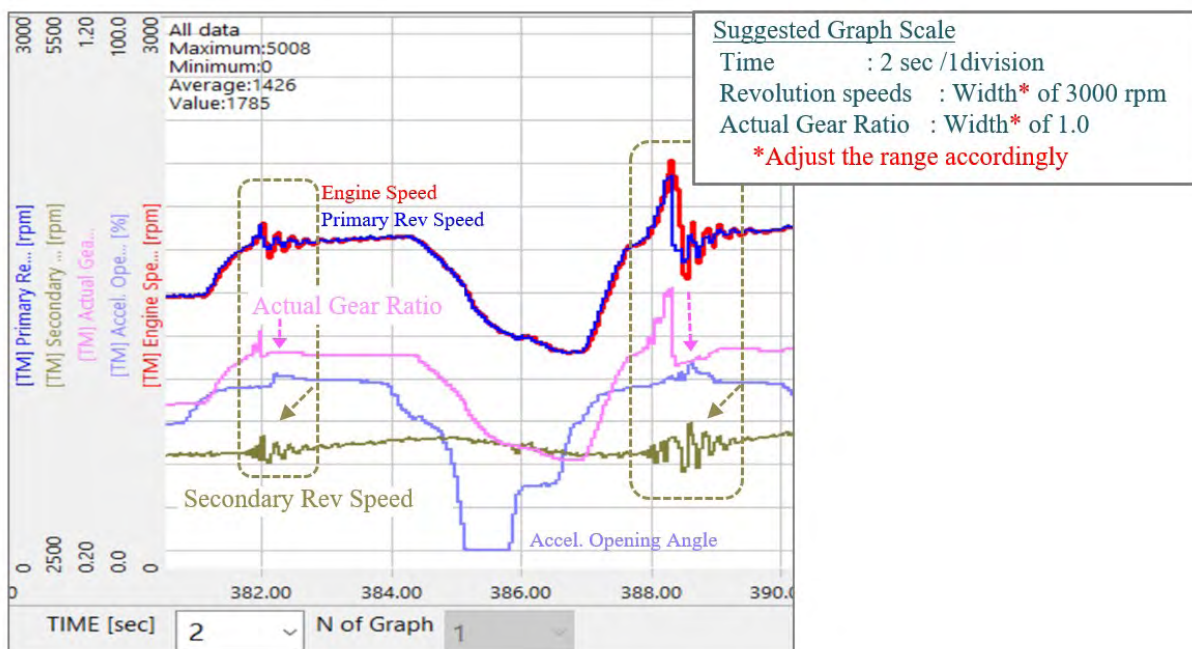
## 2. Short-Time Slip:

When a short-time slip occurs, the changes in the Actual Gear Ratio monitor will be larger than 0.1 per 0.1 second. After the Actual Gear Ratio monitor resumes to stable conditions, distinct fluctuations in revolution speed continues.

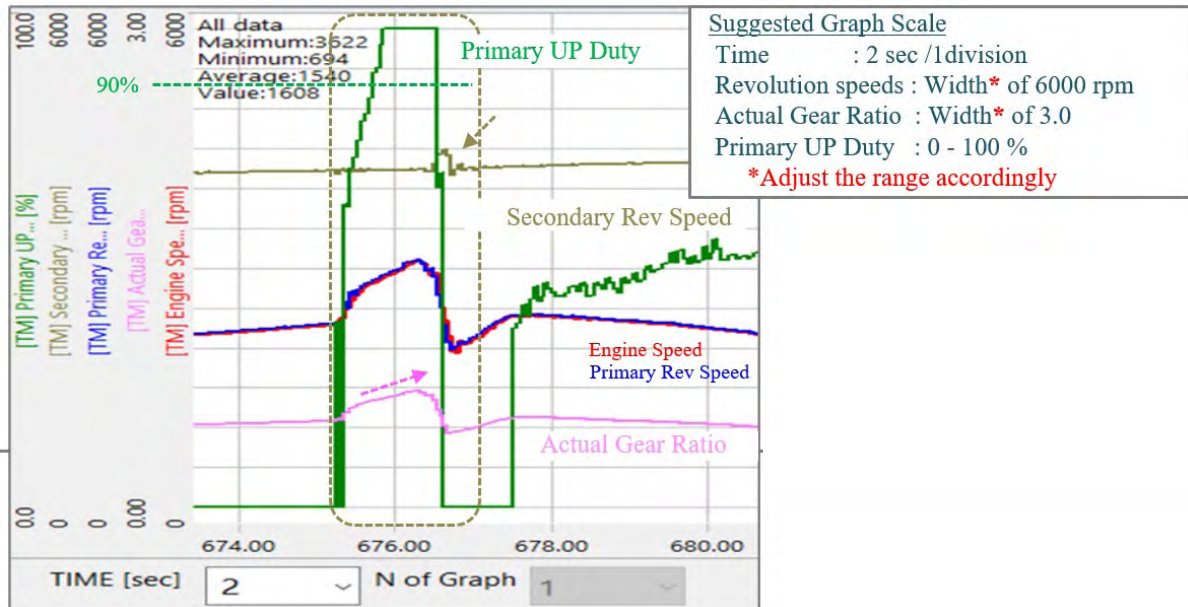
### 3. Long-Time Slip:

When a long-time slip occurs, the Primary UP Duty monitor will be larger than 90% and the Actual Pulley Ratio monitor lowers for a duration of 0.5 seconds or more. Even after the Actual Gear Ratio monitor resumes to stable conditions, distinct fluctuations in revolution speed continues.

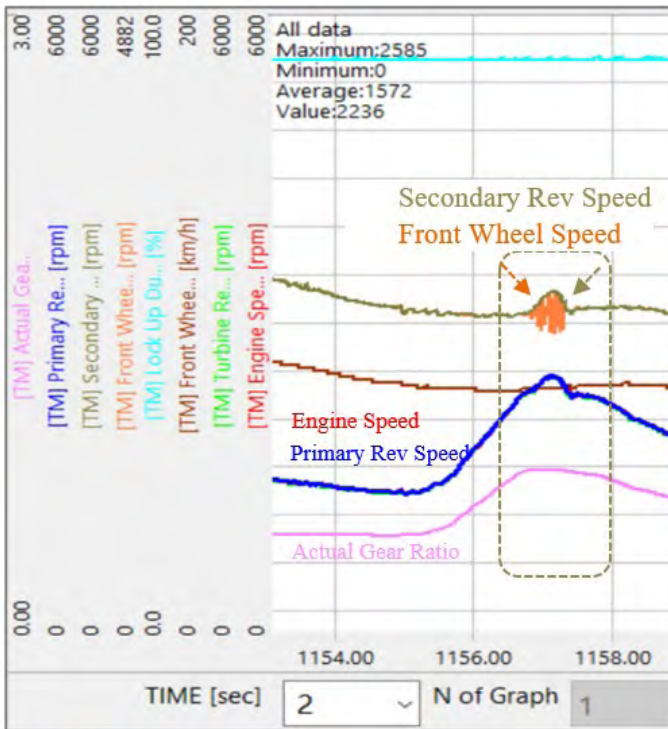
Example for  
2.4L Turbo or 3.6L NA equipped vehicles

#### 1. Forward Clutch Slip Shock:

The rotation speeds for the upstream and downstream sides of the forward clutch do not synchronize when driving.

Upstream side of the forward clutch-  
Secondary Rev Speed

Downstream side of the forward clutch-  
Front Wheel Speed

This shock can occur when the forward clutch slips. If this situation is reported, reprogram the TCM with new software if it is available.

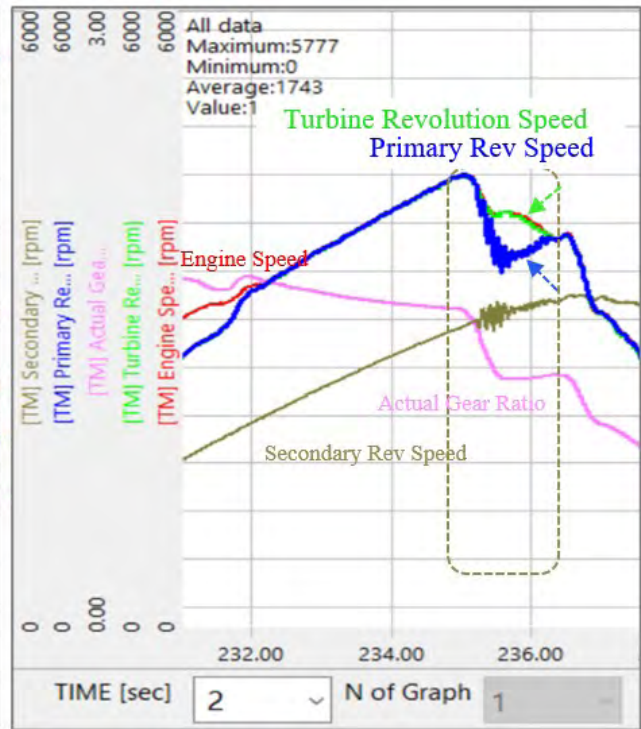
Example for vehicles **WITHOUT**  
2.4L Turbo or 3.6L NA

Upstream side of the forward clutch-  
Turbine Revolution Speed

Downstream side of the forward clutch-  
Primary Rev Speed
