Articles Contained in this Issue

01 TechShare QMR of the Month

15 Charging Cables and Touch Screen Concerns (CONTINUED)

15 CP1 Navigation shows the wrong location

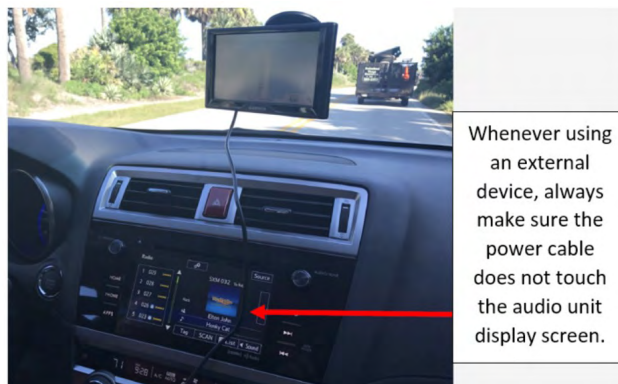
Please be aware that charging cables should not be routed in front of any touch device such as the Denso F10, Harman Headunits, and CP1 Cockpit Display. Routing the cables across the touch screen can cause erratic operation of the screen. This is referred to as 'ghost touch'. This is caused by an electrical pulse through the wire being interpreted as an input by the screen. This unwanted input can cause intermittent screen concerns and even unit crashing. This concern can be traced back to the first Denso F10 Units.

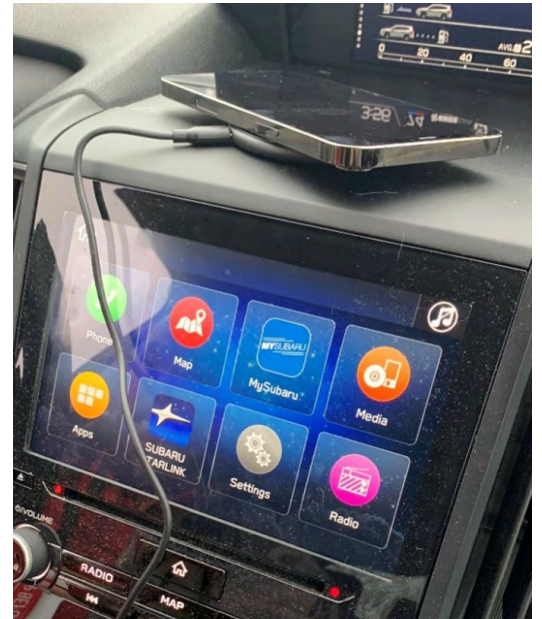
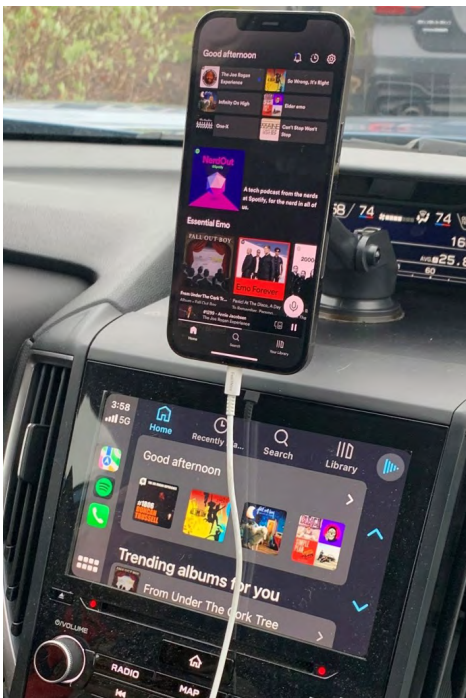
Pictured to the right, is an example from Techline of a customer with a wireless charger mounted to the pocket above the Headunit. The Customer concern was intermittent no response from the touch screen and screen distortion. Not only is the charging cord across the screen but the electromagnetic effect of the wireless charger. In some vehicles this may affect speaker performance.

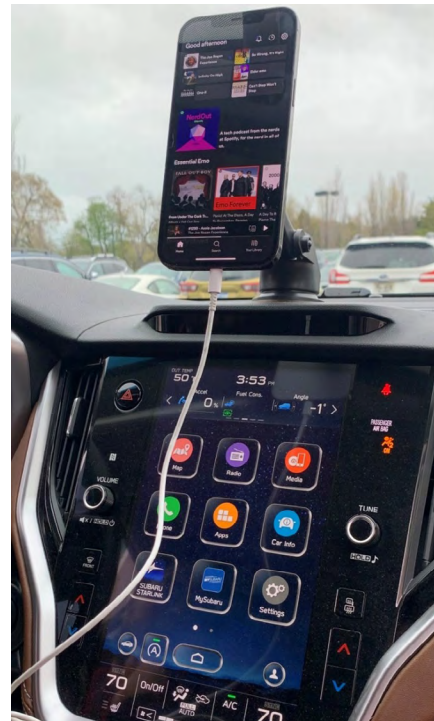
Pictured to the left, is an example of a phone mount and charging set up that could affect the screen responsiveness and behavior. Projection apps can be affected by this concern as well.

Finally, with the addition of CP1 to the Subaru lineup, there is a much larger screen where multiple inputs can be made. Shown to the right is an example of how a charging cord could affect the screen. This is especially noticeable in radio mode or a screen with several selections such as SXM or Navigation. This could cause a no response situation or screen distortion until the key is cycled and the cord is removed.

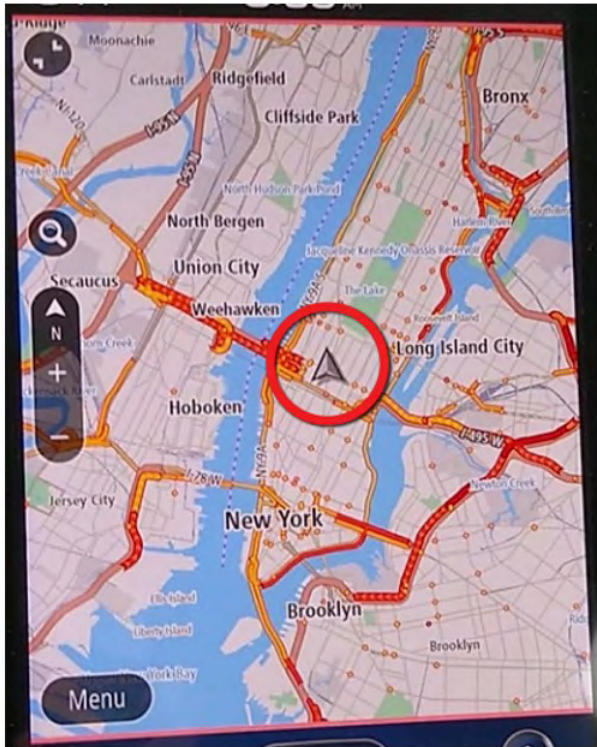
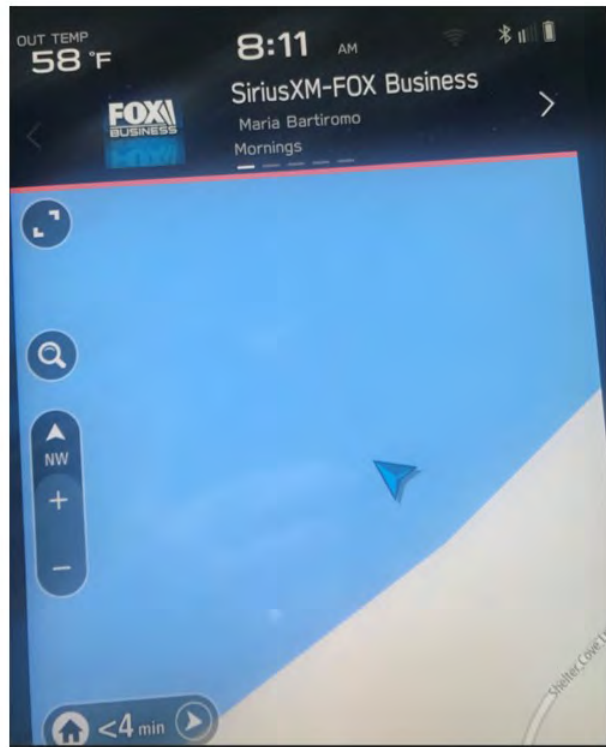
Retailers may receive vehicles with a customer complaint of the navigation showing the wrong location. This condition may show the vehicle a few miles off from the current location, the wrong town, the wrong state, or out in open water. The following instructions will clear the condition and explain how to reset the vehicle properly. Failure to follow these steps will not resynchronize the unit and may lead to unnecessary part replacement.

Below are two examples of common wrong locations seen.

Note: The default GPS location for CP1 is Manhattan, New York. The arrow icon could be gray, which indicates the vehicles' location is not found by the Navigation satellites (shown above).

1. Verify the condition.
2. Install the newest logic as per TSB 15-261-20R; refer to the TSB for the latest version.
3. Document the customers' settings, radio stations, favorites, and saved locations.
4. Perform a 10-minute capacitive discharge.

It is recommended that no short cuts be taken at this time. Failure to meet the allotted capacitive discharge time may not erase the memory and the Technician will find the same condition present when setting the vehicle back up.

5. Set up the customers' settings, radio stations, favorites, and saved locations.
6. Road test the vehicle in as straight of a line as possible for 10 minutes or ten miles, whichever resets the GPS arrow icon from gray to blue. Be mindful of the road test route selected.

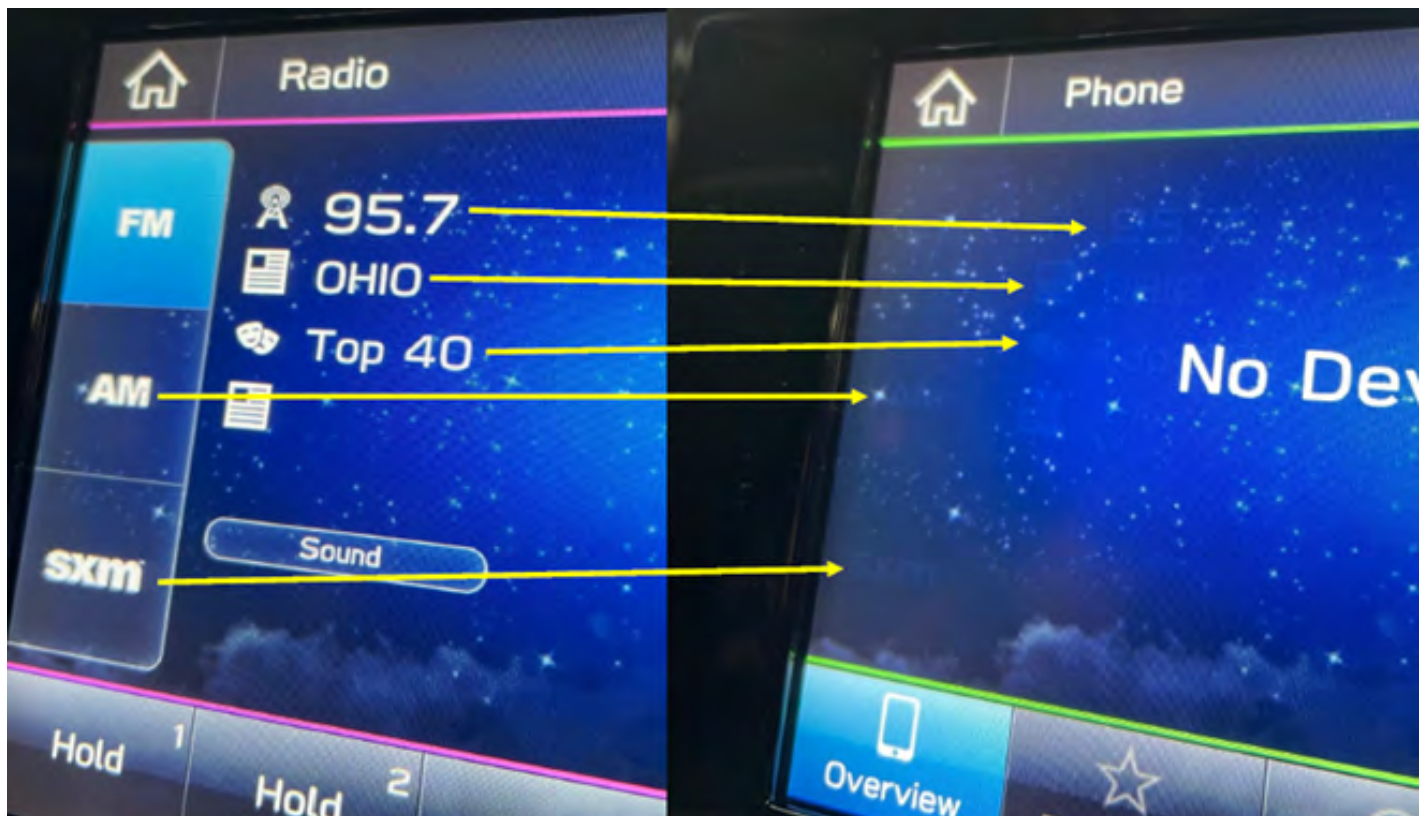
If a customer is concerned with a Ghost Image or Double Image on a Base+ or Base Harman unit, this condition requires no repair at this time. The vender has determined that this condition is non detrimental to the operation of the Headunit and will clear with time as the unit is used. The exchange process is NOT recommended for this concern.

Refer to the images below for an example of the condition.
