HYUNDAI Technical Service Bulletin

GROUP BODY	NUMBER 23-BD-006H
DATE APRIL, 2023	MODEL(S) IONIQ 5 (NE1)

SUBJECT: TAILGATE RATTLE NOISE REPAIR

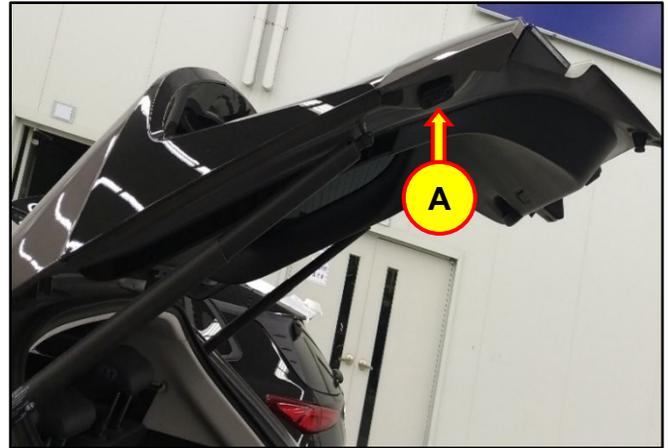
1. Open the tailgate and locate the side guide bumper (A).
