ENGINE ELECTRICAL 23-EE-006H

**Technical Service Bulletin**

SONATA (DN8)

JE202 JOINT CONNECTOR REPAIR (P049D,P0405,P0489,P0191,P0507 AND/OR P240F)

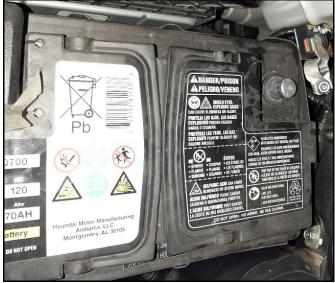
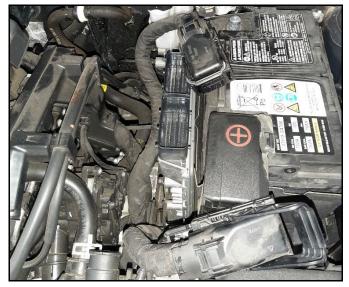
**Description:** This bulletin provides the procedure to repair poor pin tension at joint connector JE202 in certain Sonata (2.5L GDI engine) with one or more DTC.

3. Disconnect both PCM Connectors.
