HYUNDAI Technical Service Bulletin	GROUP BRAKE	NUMBER 23-BR-001H
	DATE APRIL 2023	MODEL(S) IONIQ HYBRID (AE HEV) IONIQ PLUG-IN (AE PHEV)
SUBJECT: ELECTRIC PARKING BRAKE (EPB) DTC C2416 OR C2417 DIAGNOSIS

Description: When servicing any of the specified vehicles below with the corresponding DTCs, C2416, “Motor Short or Open – LH (EPB)” or C2417 “Motor Short or Open – RH (EPB)”, follow the step-by-step procedures in this bulletin.

APPLICABLE VEHICLES: All 2019-2022MY Ioniq Hybrid (AE HEV) and Plug-in Hybrid (AE PHEV) vehicles equipped with an Electronic Parking Brake (EPB)

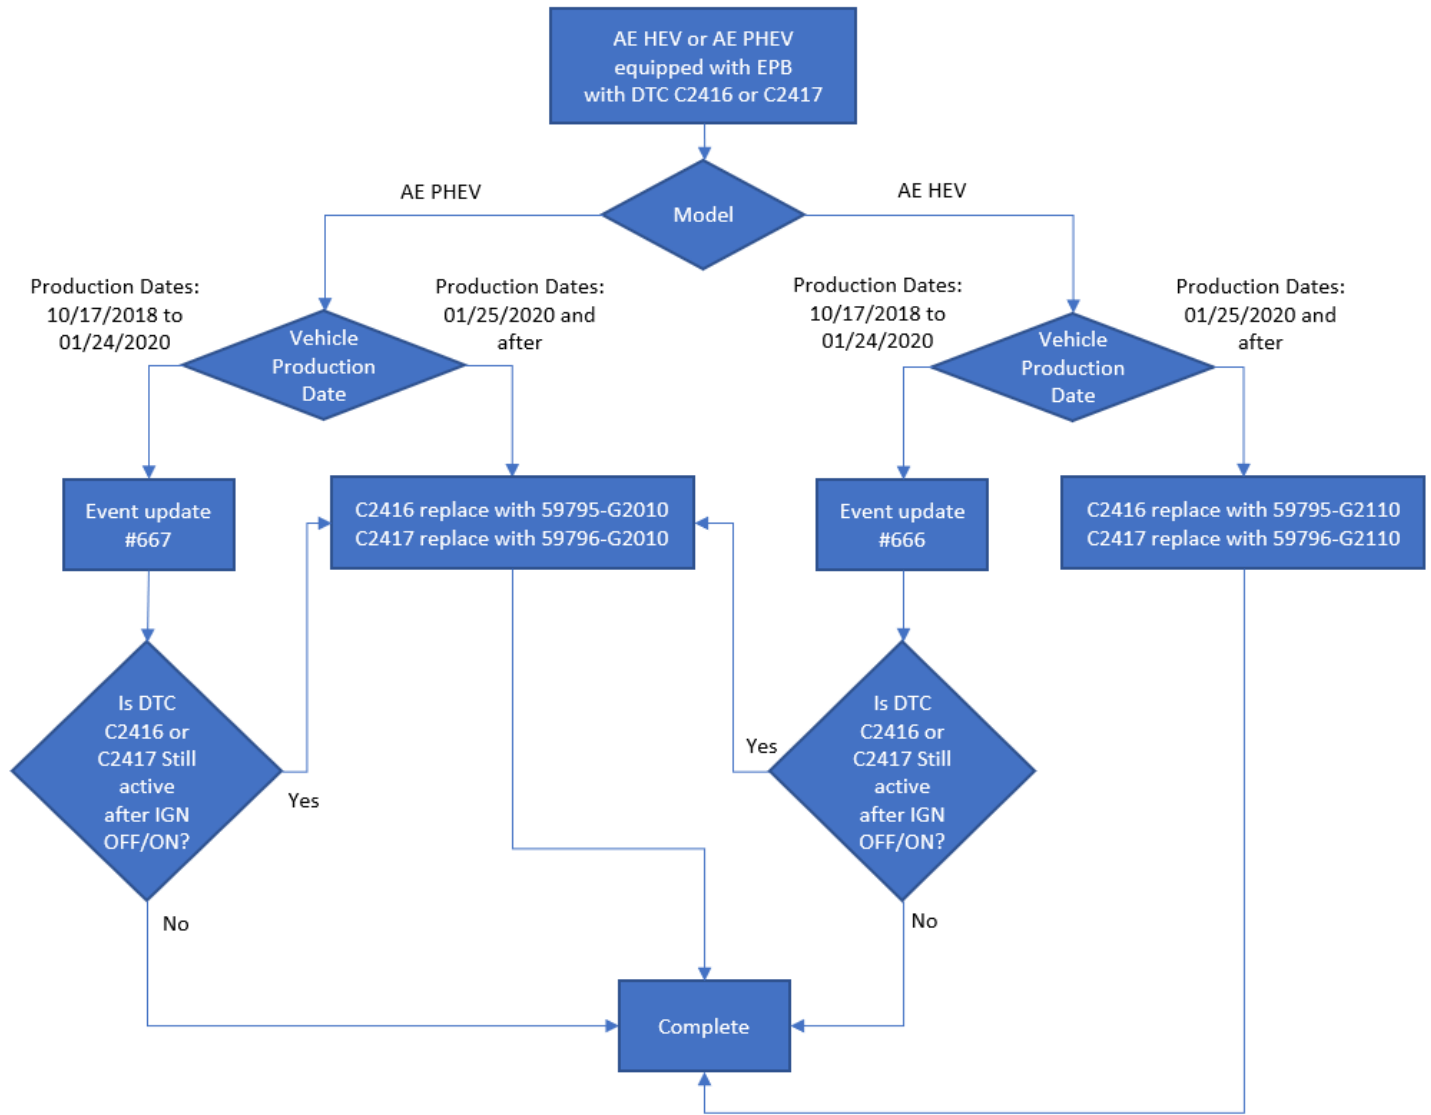
FLOW CHART:

- The DTCs stored within the vehicle may show more than the base 5-digit code. Please use the first 5-digits to determine the appropriate repair.
- Either Active or History DTC.

1. Follow the above Flow Chart for repairs.
2. If Event Update #666 or #667 is necessary, refer to TSB# 21-BR-004H or latest version, EPB ECU UPDATE FOR DTC C2416 OR C2417.
