Display of “Coolant temperature too high” in Group V6 and V8 Engines

Vehicles Affected

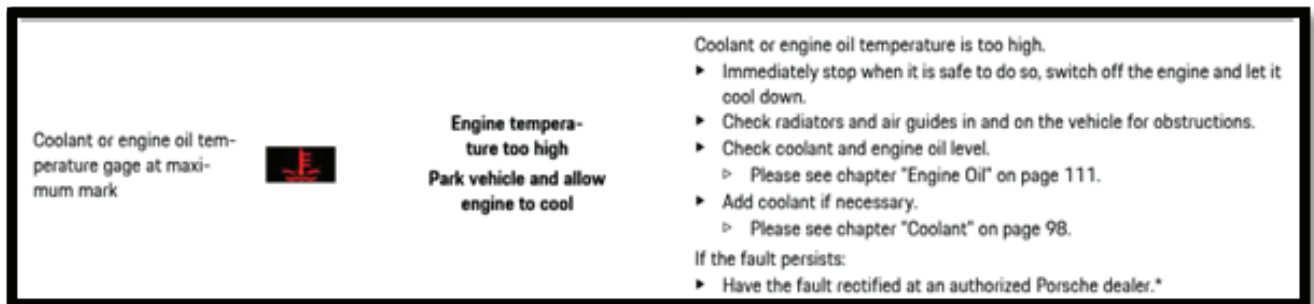
Figure 1 - Owner's Manual Information for Over-Temperature Warning (B19A750)

Customer complains about “Coolant temperature too high” warning message, Instrument Cluster fault code B19A750.

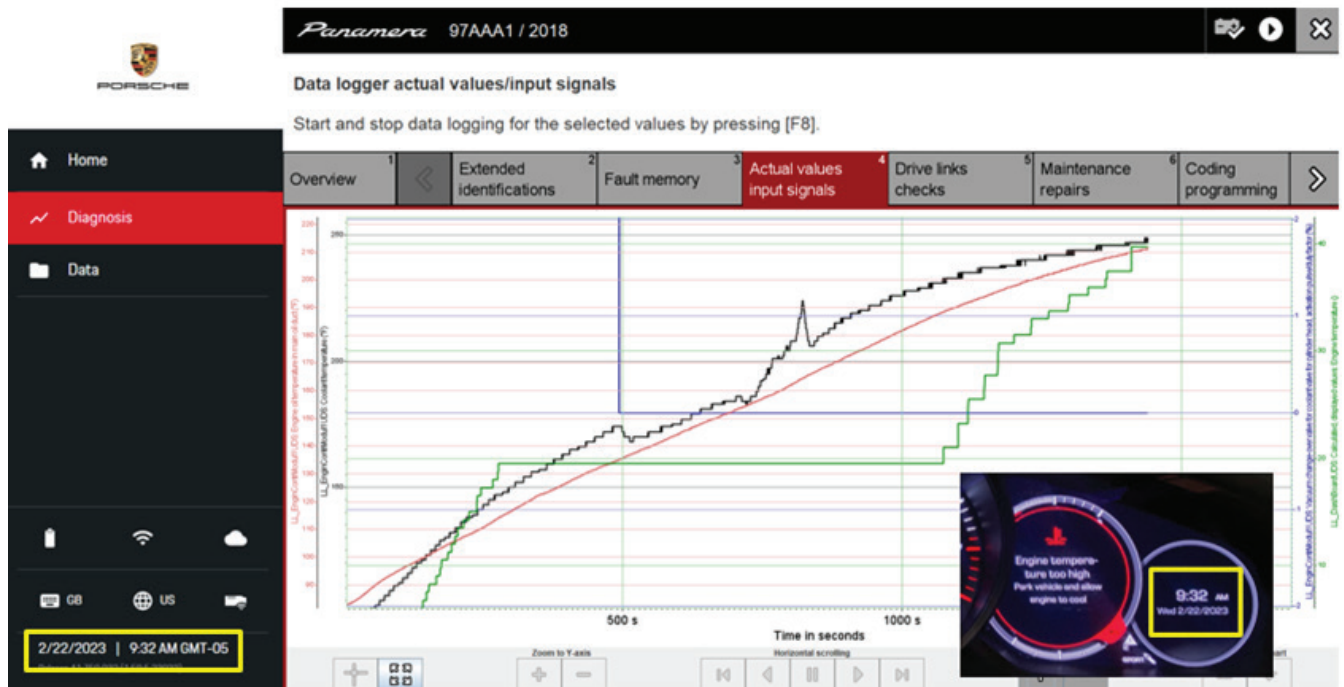
Figure 2 - Tester Tracing of Forced Overheating from Overridden Water Pump Changeover Valve

The aforementioned warning message in the instrument cluster (IC) only displays when the coolant temperature exceeds the warning threshold. The vacuum changeover valve controlling the water pump's sleeve in the aforementioned engines is known to intermittently stick, thus causing the overheat warning in the IC.

Figure 2 simulates an overheat condition by overriding the changeover valve for the coolant pump sleeve. For this simulation, the valve's electrical connection to the DME remained intact, but the simulation removed the valve from the vacuum lines, forcing the coolant pump's sliding sleeve to remain in the blocked flow position (no coolant circulation). Thus, the simulation's data of Figure 2 shows a 'forced' overheat condition from cold-start. In this simulation, the DME commands the changeover valve to switch, opening the pump's sleeve, allowing coolant to circulate (if the valve was connected). The blue series line shows this switch around 500 seconds of engine run time. Because the valve is not in-line with pump's vacuum supply (removed except electrically), the sleeve never opens, and the IC warning "Display of coolant temperature too high, active" results after approximately 25 minutes.

Please follow the function test as outlined in "TI, 1950 Warning Message "Coolant Temperature Too High": Checking Coolant Pump and Change-Over Valve (173/21)" The vacuum changeover valve controlling the water pump's sleeve in the aforementioned engines is known to intermittently stick, thus causing the overheat warning in the IC. Therefore, it is imperative to check its function as thoroughly as possible under various temperature conditions, because temperature can play a role in its behavior.

Please follow the referenced TI and appropriate workshop manuals for any work deemed necessary.
