**APA1 - Replacing Additional Pump (Stop Delivery / Recall Campaign)**

Revision: This bulletin replaces bulletin Group 8 18/23 APA1, dated March 24, 2023.

Model Line: **Panamera (971)**

Concerns: **Additional pump for air conditioning control**

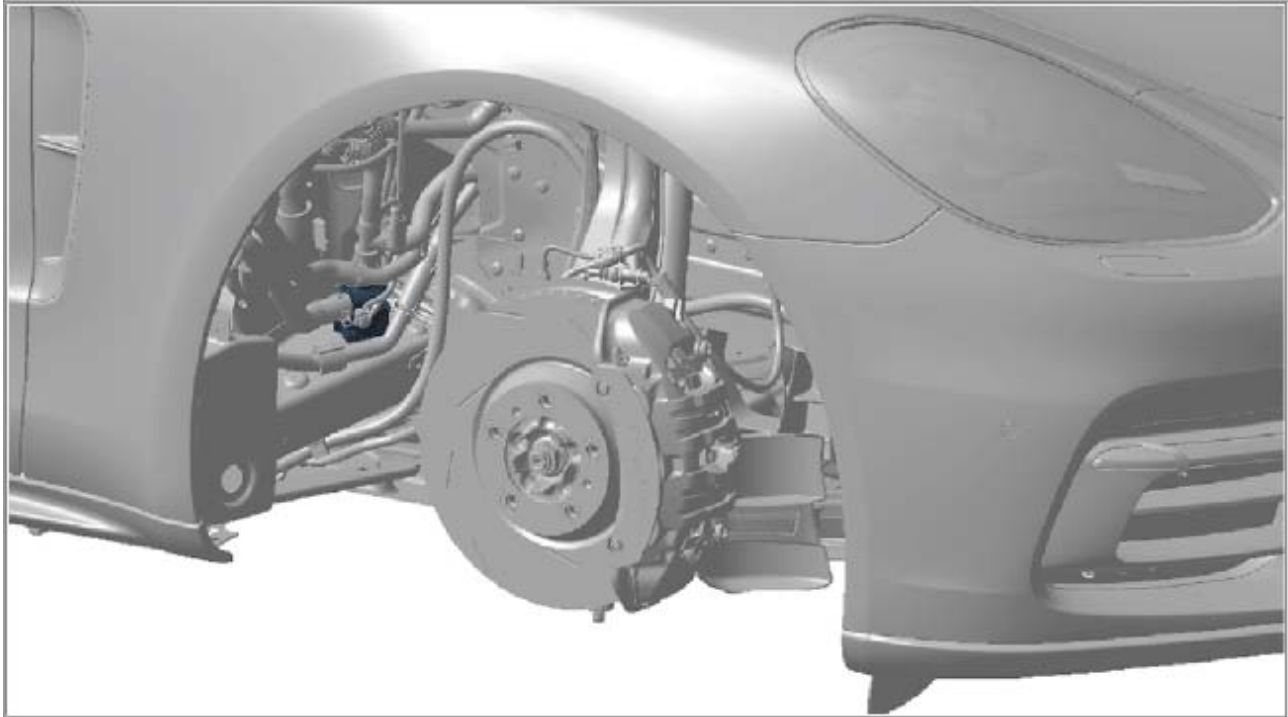
Information: **On the affected vehicles, there is a possibility of moisture getting into the control unit for the additional pump of the climate control system and causing malfunctions in the temperature control of the interior and when the engine residual heat function is activated.**

Over the service life of the vehicles, such malfunctions can lead to short circuits and promote visible damage to the additional pump successively to the plug connection of the wiring harness. As damage progresses, an unnoticed short circuit can lead to an increased risk of scorching and even fire. Activating the AUTO-REST button in the center console can cause fire damage even longer after stopping the vehicle.

*Installation position of additional pump*

Action required: Replace additional pump for air conditioning control and check plug connection and replace if necessary.

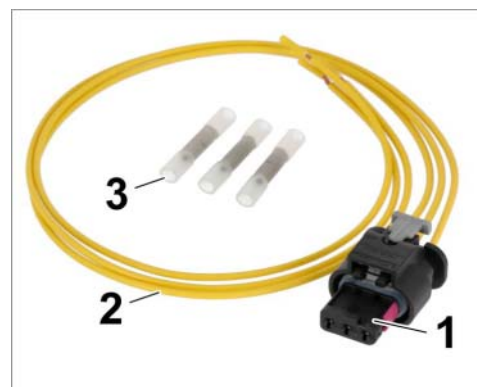
*Overview of connector repair kit*

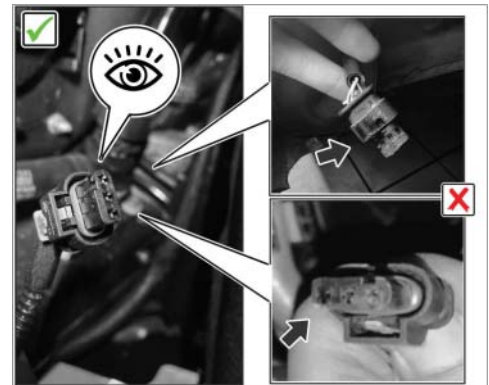
Checking connector

2 Check connector connection for additional pump for visible thermal deformations.

- If no damage to the connector is visible, **continue with Step 3.**
- If damages to the connector are visible, document this with a digital camera and repair the connector. Please claim the part number APA10000005 for the remaining cost of the APA1 connector kit that your dealer was charged, max amount \$10.49. Please use designation "Shipping Costs" or "Price Difference" when claiming. To do this, **continue with** ⇒ *Technical Information '803719 repairing the plug connection for the additional pump'*.

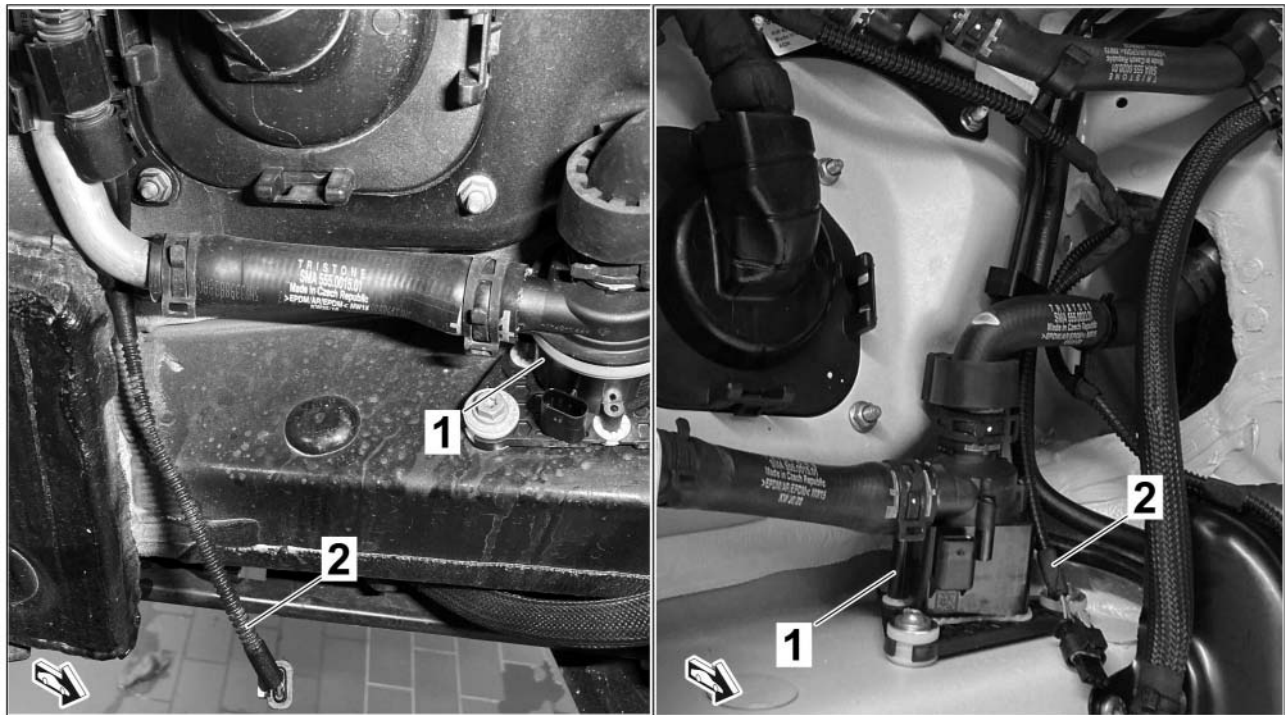
Depending on the model year and equipment variant, the wire harness for the additional pump ⇒ *Wire harness routing -2-* is routed ⇒ *Wire harness routing -1-* either at the left or right of the additional pump.

*Wire harness routing*

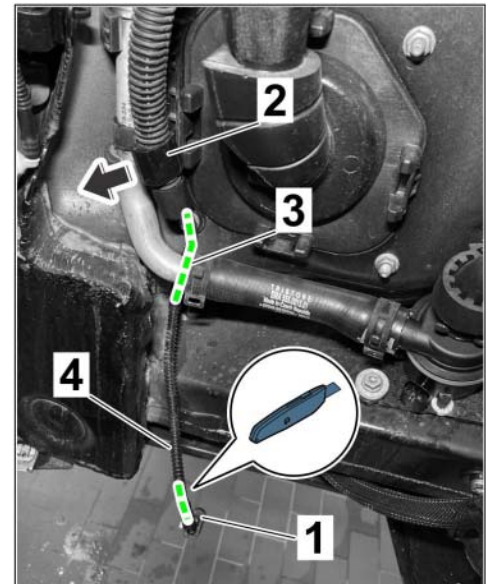
*Expose wire harness*

- 6 Expose wire harness for additional pump.
  - 6.1 Release retaining clips ⇒ *Expose wire harness -1-* on wire harness ⇒ *Expose wire harness -2-* ⇒ *Expose wire harness -Arrow-* and pull out the wire harness.
  - 6.2 Remove insulating tapes on the corrugated tube ⇒ *Expose wire harness -4-* at the top and bottom.
  - 6.3 Pull wire harness out of the corrugated tube up to the branch area of the wire harness.

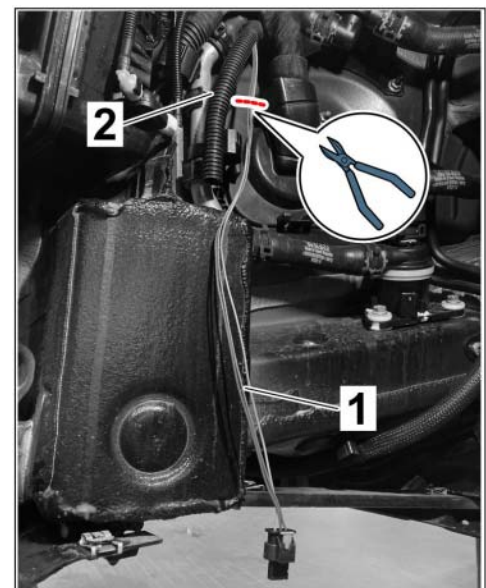
*Repair wire harness*

- 7.1 Cut wire harness ⇒ *Repair wire harness -1-* individually using a side cutter or **stripping pliers VAS 1978/ 3** in the marked area (connection point approx. 280–300 mm from connector).  
The connection point should be located at the top of the corrugated tube ⇒ *Repair wire harness -2-*.

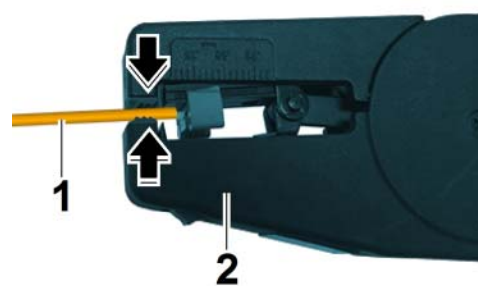
*Stripping the line*

- 7.2 Strip the ends of the line you have just cut  
 ⇒ *Stripping the line -1-* using the **stripping pliers VAS 1978/3** ⇒ *Stripping the line -2-*.

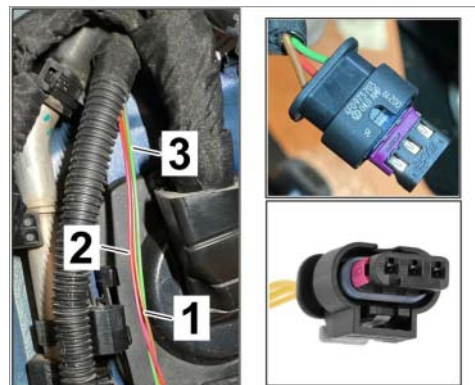
*Pin assignment*

- 7.3 Connect lines individually according to pin assignment.

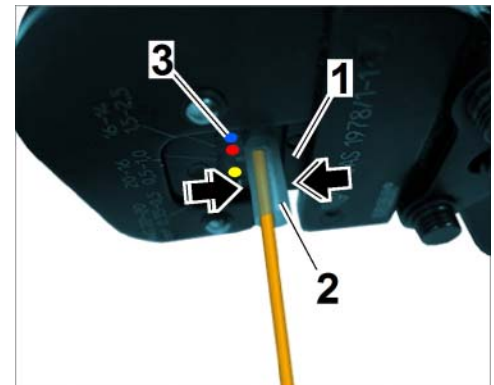
*Crimping on line*

- 7.5.1 Install crimping pliers insert  $\Rightarrow$  *Crimping on line -1-* according to the color marking  $\Rightarrow$  *Crimping on line -3-* on the crimp connector  $\Rightarrow$  *Crimping on line -2-* into the **crimping pliers VAS 1978/1-1**.

- 7.5.2 Crimp on the crimp connector  $\Rightarrow$  *Crimping on line -2-* using **crimping pliers VAS 1978/1-1**.

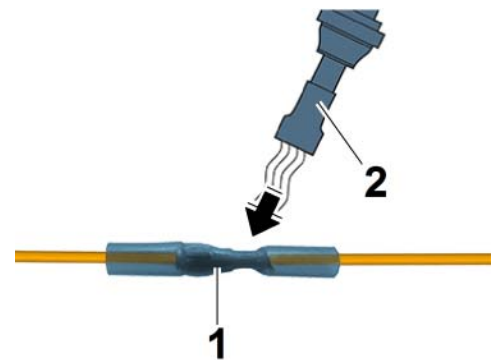
*Sealing crimp connection*

- 7.6 Seal shrink-fit hose on the crimp connection  $\Rightarrow$  *Sealing crimp connection -1-* using **hot-air blower VAS 1978/14A**  $\Rightarrow$  *Sealing crimp connection -2-*.

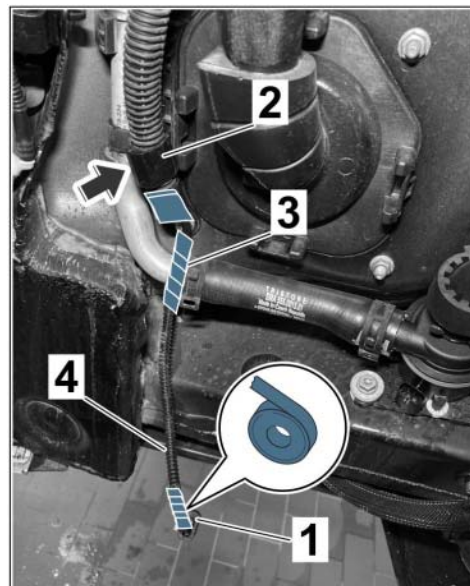
*Wrapping tape around wire harness*

- 8 Route wire harness for additional pump.
  - 8.1 Press wire harness ⇒ *Wrapping tape around wire harness -1-* into the corrugated pipes ⇒ *Wrapping tape around wire harness -4-*.
  - 8.2 Wrap insulating tape ⇒ *Wrapping tape around wire harness -3-* around the lines in the connector in the usual way.
  - 8.3 Route wire harness around the water line again.
  - 8.4 Fasten ⇒ *Wrapping tape around wire harness -2-* wire harness to the retaining clip ⇒ *Wrapping tape around wire harness -Arrow-*.
- 9 Plug in connector on the additional pump and check wire harness for correct routing and clearance.
