Lightweight Glass Panes Cracked – Identification and Possible Causes

Models	Model Year	Model Type	VIN Range	Vehicle-Specific Equipment
911	2021 - 2023	992110 992120 991130 992140 992150 992410 992420 992430 992440 992450 992460 992810 992820 992850	n/a	+VW4

This document addresses various cracks in the lightweight exterior glass panes of the 911.

This document only applies to vehicles with the option VW4 – Lightweight and Noise Insulated Glass.

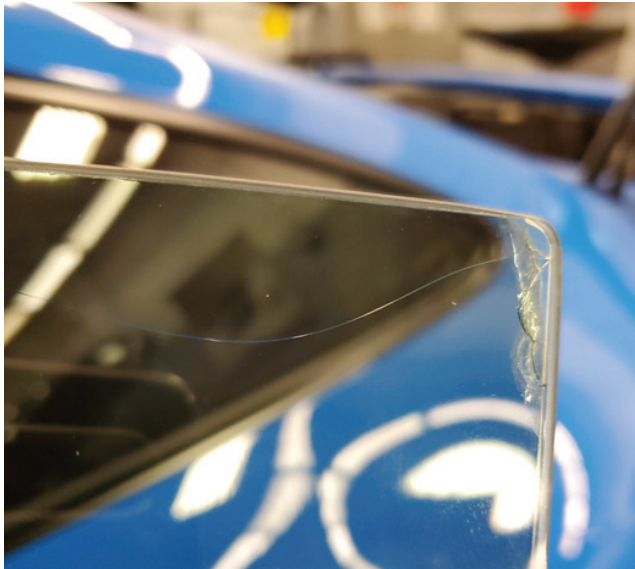
Figure 1 - Driver's door glass: cracks in the top corner

There are two main causes for this condition:

- > The door glass is misaligned, which can cause contact between the door glass and the rear quarter glass, or
- > Force applied to the glass (i.e., instead of the door sill) throughout the door closing process can bend the glass enough to cause contact with the rear quarter glass, despite a proper window alignment with no force applied.

Updated lightweight door glass parts have been developed to address this complaint (ETA Q2/2023). Please see the *Driver's door glass: cracks in the top corner* section of the Service Information for repair instructions.

Please replace the affected glass pane(s) as instructed in *WM 644019 – Removing and installing door window glass*.

Updated lightweight glass parts are expected Q2/2023. The updated parts will be identifiable by an "H" index part number (e.g., 992845019H or 992845020H).

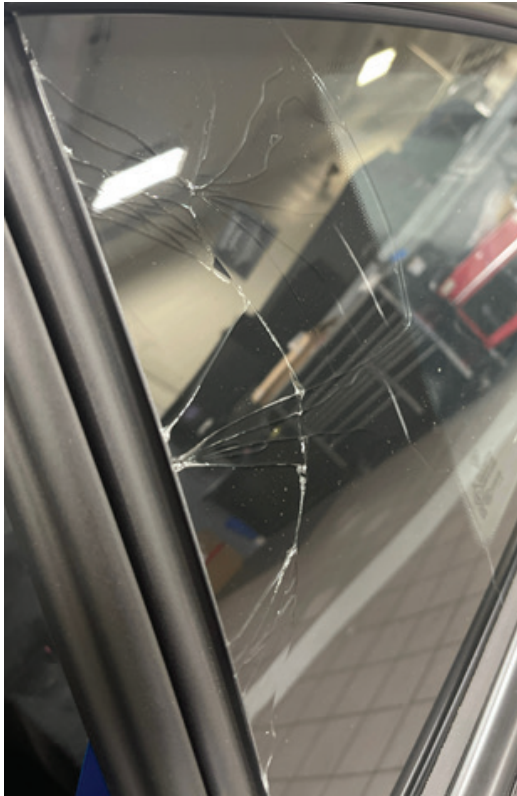
Figure 2 - Rear quarter glass (side window pane): cracks near front edge

There are two main causes for this condition:

- > The door glass is misaligned, which can cause contact between the door glass and the rear quarter glass, or
- > The quarter glass mounting nuts are over-torqued

Please see the *Rear quarter glass (side window pane): cracks near front edge* section of the Service Information for repair instructions.

Please replace the affected glass pane(s) as instructed in *WM 647519 – Removing and installing side window (Coupe)*.

Please exercise additional caution when tightening the fastening nuts for the glass pane. Applying too much torque to the fastening nuts may cause the glass pane to crack.

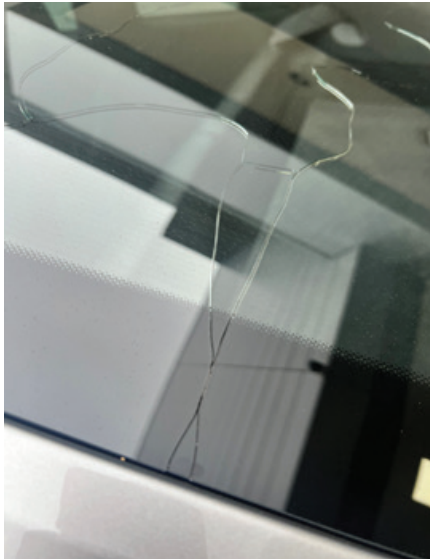
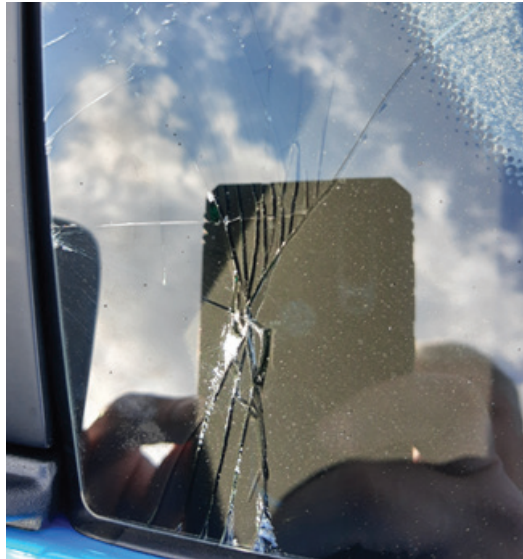
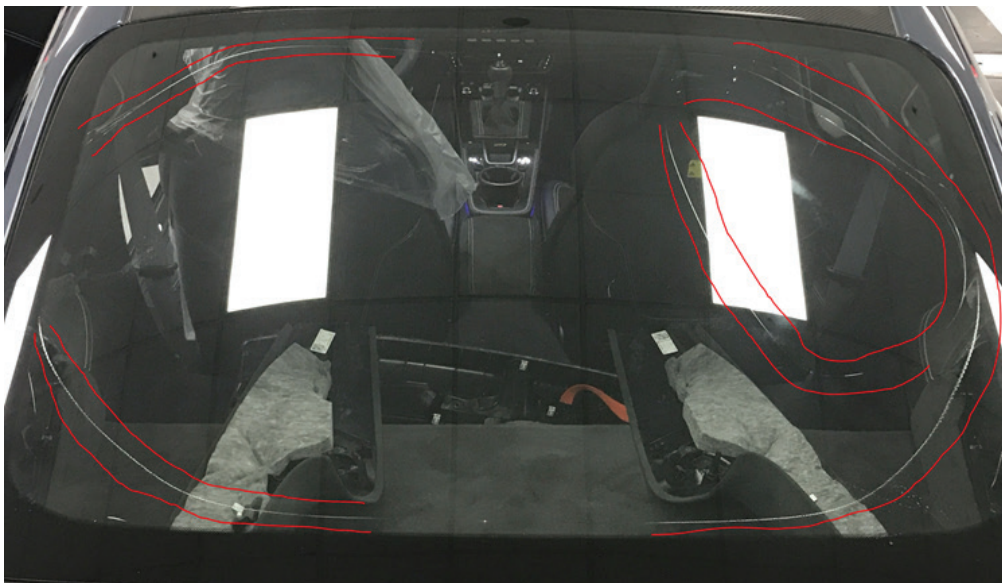
Figure 3 - Rear window glass: various cracks

Stress cracks in the rear window glass are currently being analyzed by Porsche. The root causes for the different kinds of stress cracks are unknown at the time of publication of this document.

Please see the *Rear window glass: various cracks* section of the Service Information for repair instructions.

Please replace the rear window glass as instructed in *WM 648619 – Removing and installing rear window*.

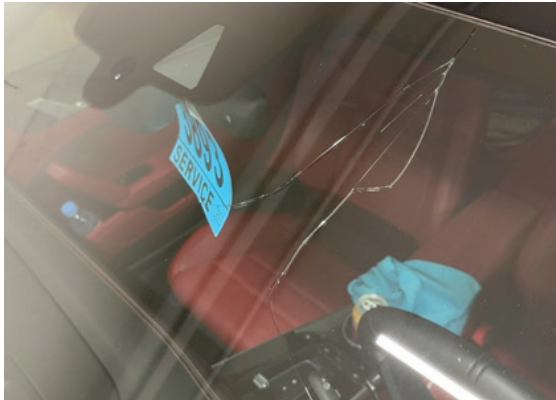
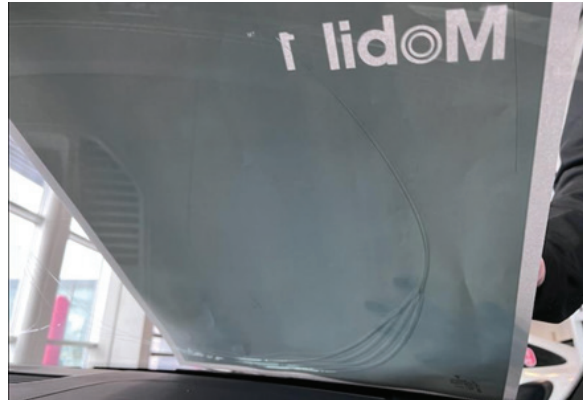
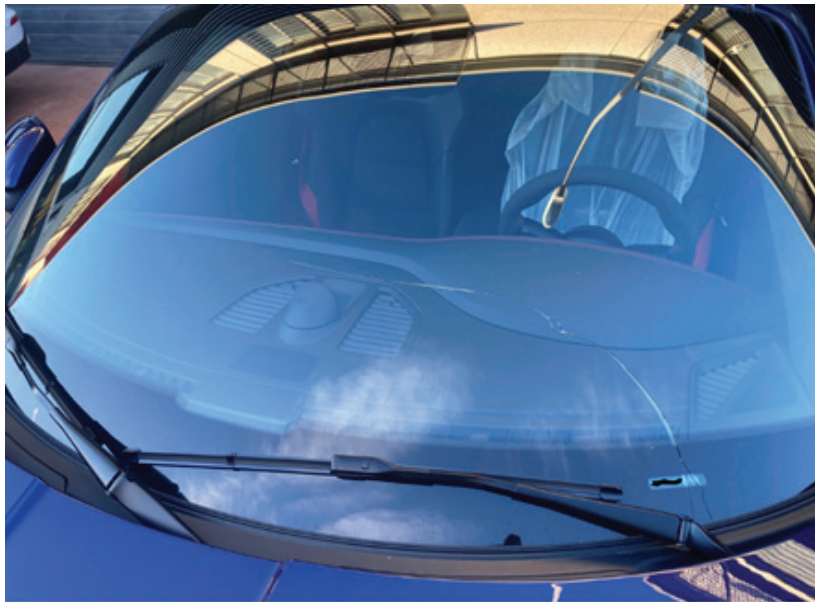
Figure 4 - Front windshield: various cracks

Stress cracks in the front windshield are currently being analyzed by Porsche. The root causes for the different kinds of stress cracks are unknown at the time of publication of this document.

Please see the *Front windshield: various cracks* section of the Service Information for repair instructions.

Please replace the front windshield as instructed in *WM 641219 – Removing and installing rear windscreen*.
