Service Bulletin

Bulletin No.: 22-NA-172

Subject: Trailer Tire Pressure Only Reading Up To 100 PSI (689 kPa), New Parts To Increase To 147 PSI (1013 kPa)

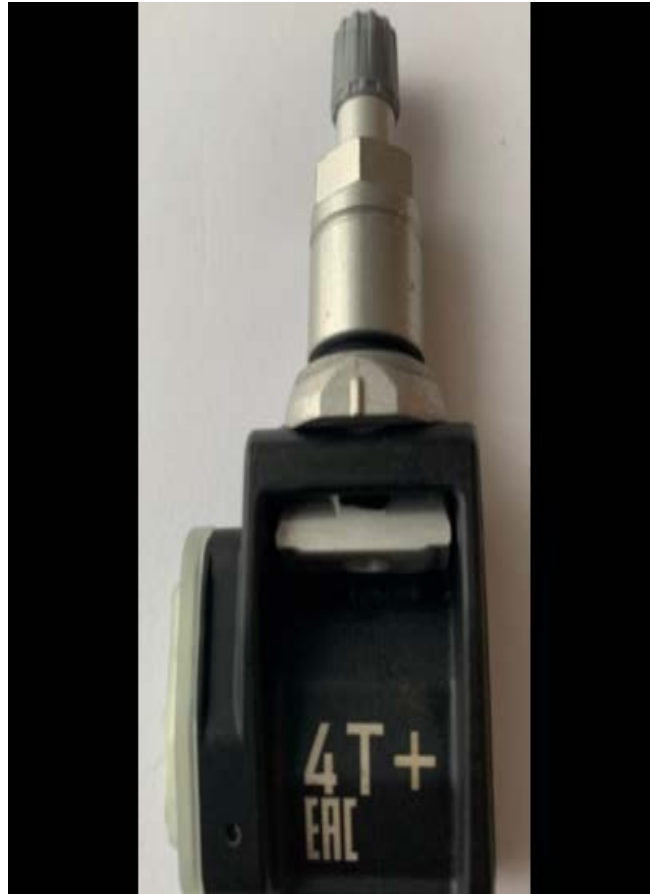
6309767

Example of the High Pressure TTPMs

Replace the TTPM *Trailer Tire Pressure Indicator Module Replacement* in the Service Manual and follow the relearn procedure, as well as the four Trailer Tire Pressure Sensors *Trailer Tire Pressure Indicator Sensor Replacement* in the Service Manual. Then reprogram the IPC.

2020 Model Year Vehicles — Replace both the TTPM and sensors then update the IPC software to V168 or higher.

2021 Model Year Vehicles — Replace both the TTPM and sensors then update the IPC software to V164 or higher.

2022 Model Year 1500 J21 Trucks — Built prior to December 1, 2021 replace just the TTPM on vehicles then update the IPC to most current software. Vehicles built after already have the new TTPM.

2022 Model Year 1500 J22 Trucks — **DO NOT** need to replace the TTPM or sensors, ensure the IPC software is V164 or higher.

- Vehicles built in Flint prior to October 1, 2021 replace both the TTPM and sensors then update the IPC software to V164 or higher.
- Vehicles built in Oshawa **DO NOT** need to replace the TTPM or sensors. Ensure the IPC software is V164 or higher.
