GROUP	MODEL
ELE	2019-2022MY Niro EV (DE EV)
NUMBER	DATE
270	April 2023

## TECHNICAL SERVICE BULLETIN

### SERVICE ACTION: INVERTER COOLANT/DEBRIS

SUBJECT: **FLUSHING/REPLACEMENT FOR CLUSTER MESSAGE  
"REFILL INVERTER COOLANT" (SA512)**

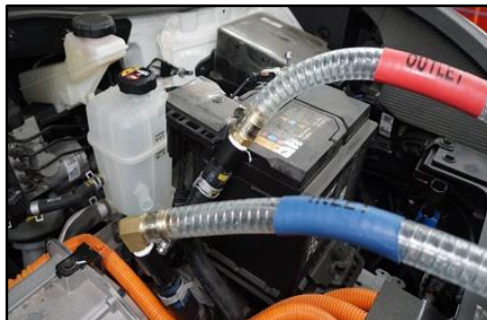
This bulletin provides information to flush out the inverter low-conductivity coolant on certain 2019-2022MY Niro EV (DE EV) vehicles produced from May 10, 2019 through October 4, 2021, which may exhibit a "Refill inverter coolant" message displayed on the instrument cluster due to poor flow of coolant/antifreeze inside the coolant pipes. In most cases, the inverter reservoir tank coolant may be filled to normal level and no DTC's are stored due to an increase operation of the electric water pump (EWP) that is 2,450 RPMs or more when checked. Follow the procedure outlined in this publication to flush out the low-conductivity coolant/debris inside the coolant pipe and replace the inverter coolant. Before conducting the procedure, verify that the vehicle is included in the list of affected VINs.
