Subject: OIL SEEPAGE OR LEAKS AT ENGINE FRONT COVER	Bulletin No.: 01-006/23
	Last Issued : 04/26/2023

2018-2023 CX-5 2.5L with cylinder deactivation

NOTE: This service information applies to vehicles with SKYACTIV-G 2.5 (PYUD engine) with cylinder deactivation.

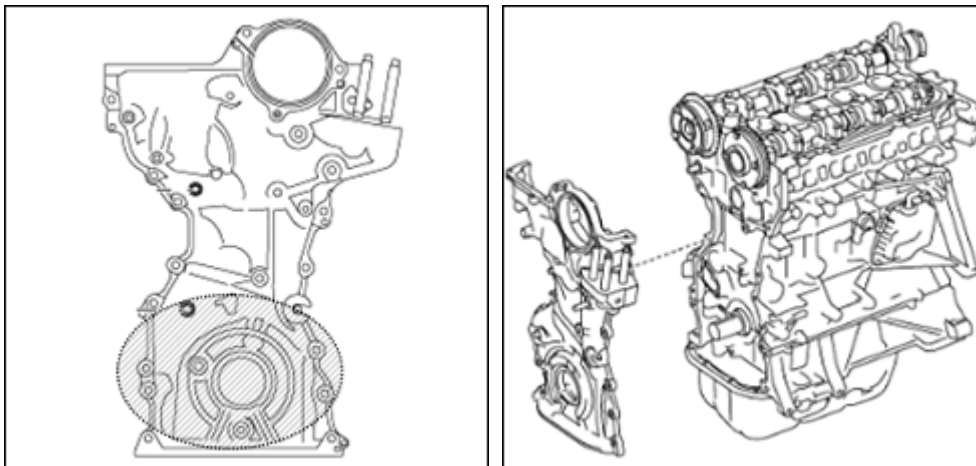
Some vehicles may exhibit oil seepage or oil leak onto the engine front cover, which becomes more apparent with dust adhesion.

Customers experiencing this concern should have their vehicle repaired using the following repair procedure.

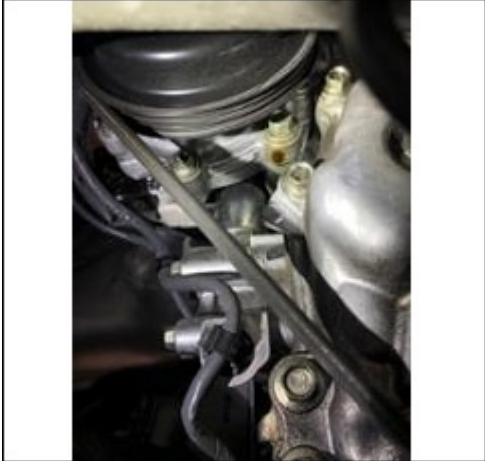
Front cover	Under cover
Need to repair	<ul style="list-style-type: none"> <input type="checkbox"/> Oil is dripping. <input type="checkbox"/> The area around the cover is heavily soiled with oil and dust. <input type="checkbox"/> Oil adheres to the oil seepage area by touching it.

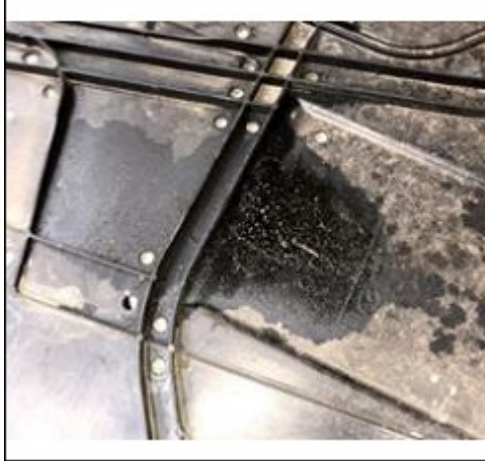
<ul style="list-style-type: none"> <input type="checkbox"/> Oil accumulation on cover. <input type="checkbox"/> Oil adheres to the oil leakage marks by touching it.

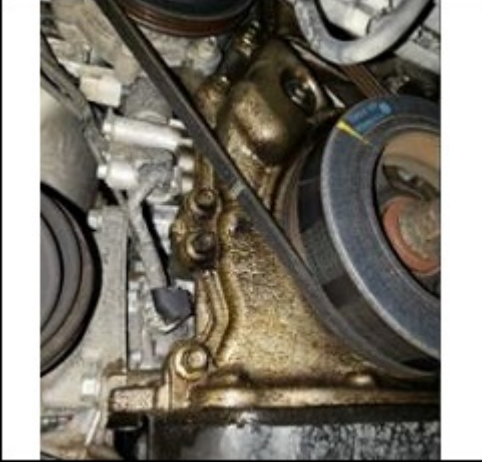
<p>No need to repair</p>	<p>The oil is completely dry by touching the oil seepage area.</p>	<p>No oil accumulation on cover.</p>

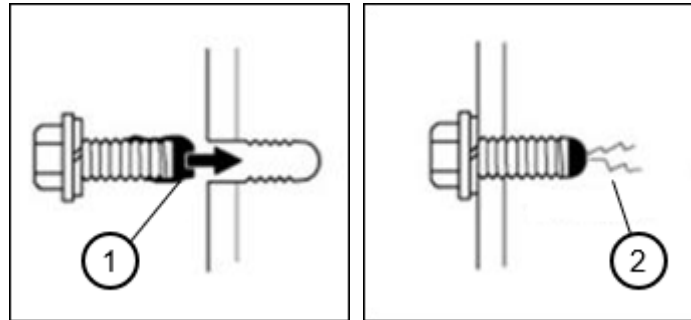
CAUTION: If a bolt with sealant (1) on it is used, it could result in cracks (2) in the cylinder head and engine block.

3. When reusing the engine front cover installation bolts, remove sealant from the bolts.

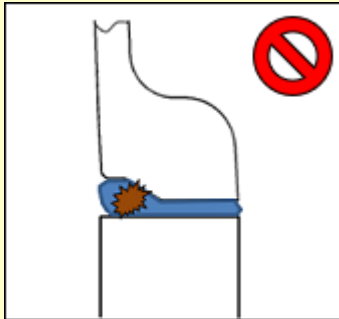
The ground contact area between the sealant and the cover is small and does not provide sufficient sealing.

Dust gets into the mating surfaces

- 1 □ Clean and degrease the mating surfaces.
- 2 □ Apply the proper amount and location of sealant.

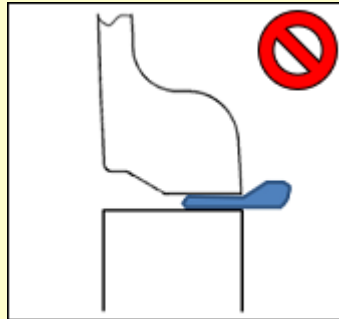
The place of application is out of alignment

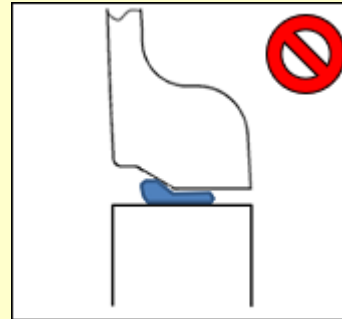
Too little sealant

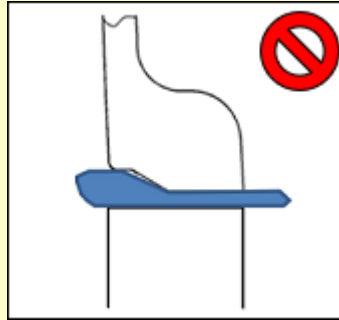
Overlapping sealant may adversely affect internal engine parts.

Too much sealant

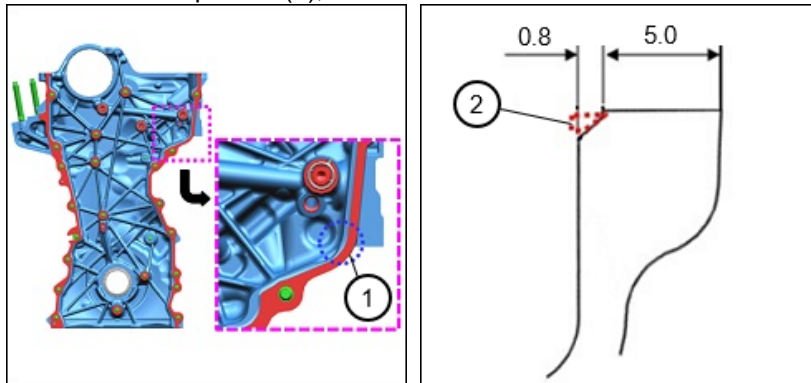
The following areas (1) have a smaller step bead (2), so be careful about the amount and location of sealant application.
