Technical Service Bulletin

Mazda North American Operations
Irvine, CA 92618-2922

Subject: WRINKLES ON LEATHER SEAT SURFACE OF NEW (UNSOLD) VEHICLE	Bulletin No.: 09-007/23
	Last Issued : 04/03/2023

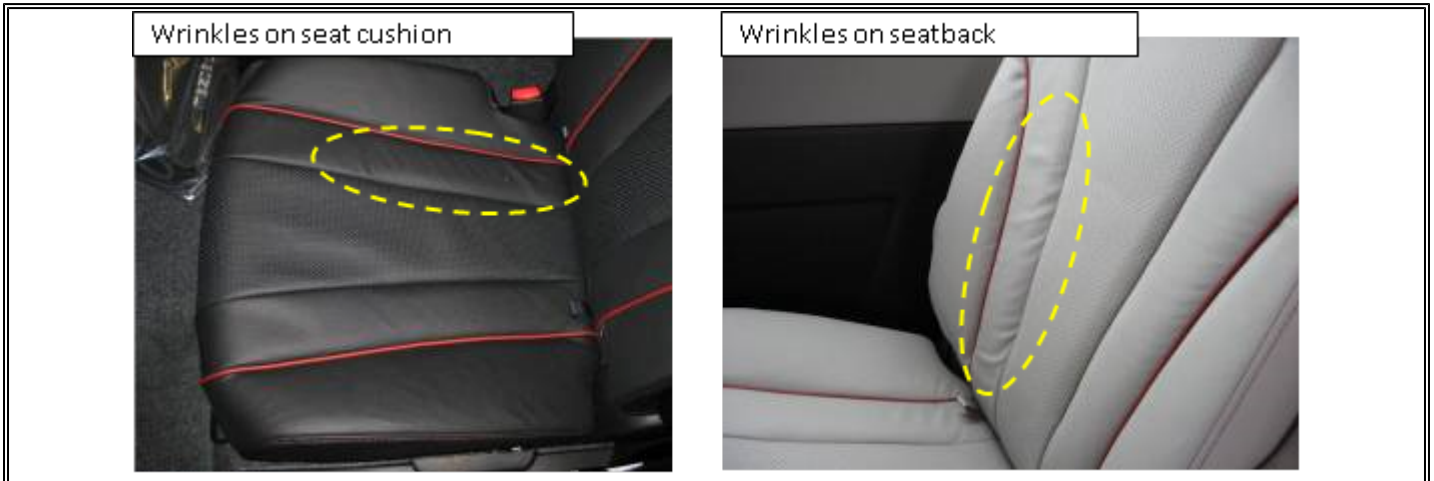
At PDI or when new vehicle is delivered, some customers may complain about wrinkles on the leather seat cushion

and/or seat back surface.

Customers experiencing this concern should have their vehicle repaired according to the following repair procedure.

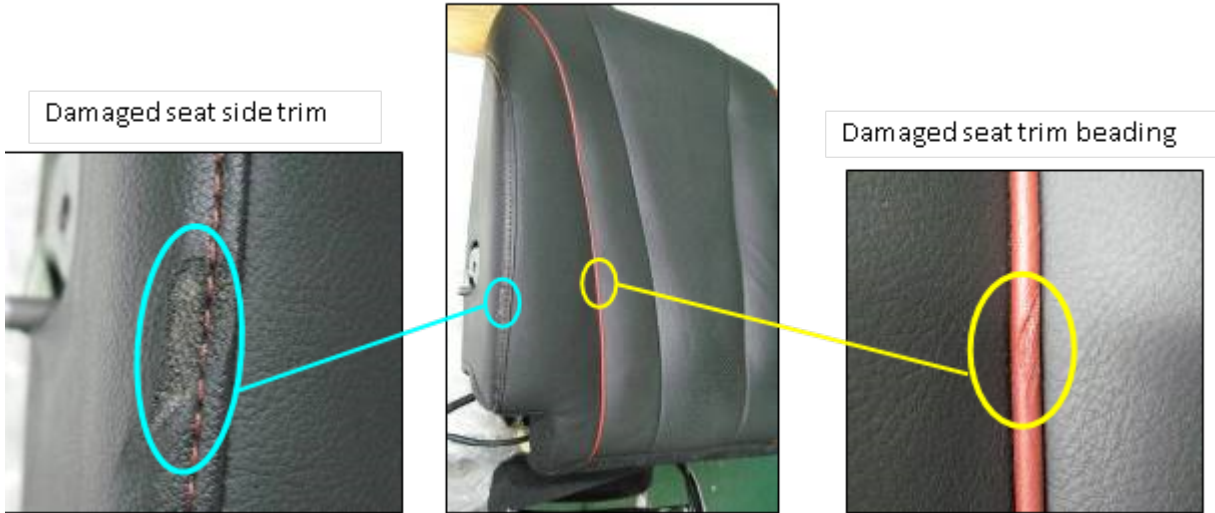
- **DO NOT** keep the iron in the same area for a long time. Doing so could damage the seat surface, as shown below.
- **DO NOT** run the iron without a water-soaked cloth, especially over the seat trim beading and seat side trim areas.
