Technical Service Bulletin

Subject: ELECTRICAL DEVICES CANNOT BE CHARGED AT REAR CONSOLE OR TRUNK SIDE TRIM USB POWER OUTLET	Bulletin No.: 09-013/23
	Last Issued : 04/28/2023

2016-2023 CX-9 vehicles with VINs lower than JM3 TC**** ** 630018 (Produced before Aug. 1, 2022)

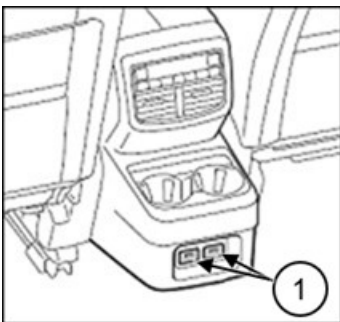
Rear Console

Some customers may experience electrical devices that cannot be charged through the rear console or the trunk side trim USB power outlet. This may be caused by an excessive external force applied to the USB power outlet. To eliminate this concern, the soldering strength of the USB port has been enhanced.

1. Verify the customer concern.
2. Replace the USB power outlet (1) on the rear console or trunk side trim with a modified part according to the instructions on MGSS online: (USB POWER OUTLET REMOVAL/INSTALLATION)
