Technical Service Bulletin

Subject: FRONT DOOR INTERFERES WITH REAR DOOR GARNISH (4-DOOR SEDAN)	Bulletin No.: 09-018/23
	Last Issued : 04/11/2023

2019-2021 Mazda3 (Japan built 4-door sedan) with VINs lower than JM1BP*****402503 (produced before August 4, 2021)

2019-2023 Mazda3 (Mexico built 4-door sedan) with VINs lower than 3MZBP*****362059 (produced before Feb. 14, 2023)

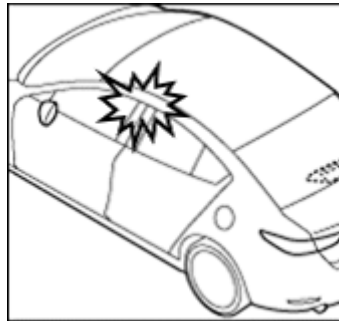
Some vehicles may exhibit the glass run channel of the front door interfering with the rear door garnish.

This is caused by the front door glass run channel not being fixed strongly enough to the door for the following situations where the cycles of door operation may result in interference and lead to damage on the rear door garnish.

- When the front door glass is closed, the glass run channel may be forced to move to the B pillar side.
- During very hot weather, the glass run channel may expand to the B pillar side.

To eliminate this concern, the design of the front door glass run channel has been changed to be fixed stronger to the door.

1. Verify the customer concern.
2. Replace the front door glass run-channels with modified ones, regardless if the other side is damaged or not, following the instructions on MGSS (FRONT DOOR GLASS RUN-CHANNEL REMOVAL/INSTALLATION).
