Technical Service Bulletin

Subject: REAR COMBINATION LIGHT(S) ARE FOGGY	Bulletin No.: 09-019/23
	Last Issued : 04/12/2023

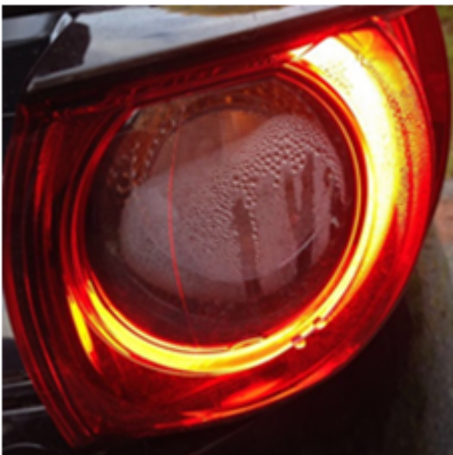
Some customers may complain of foggy rear combination lights (as shown below) after a car wash or heavy rain.

This concern may be caused by water entering into the rear combination lights through the ventilation tubes. To eliminate this concern, the configuration of the rear combination lamp has been modified to prevent water from entering through the ventilation hole.

1. Verify the customers concern of condensation inside the rear combination lights.
2. If condensation is found inside, replace both rear combination light units with **modified** parts according to the instructions on MGSS online (REAR COMBINATION LIGHT REMOVAL/INSTALLATION).
3. Verify the repair.
