Technical Service Bulletin

Subject: WARNING MESSAGE FOR DIRT ON FRONT RADAR SENSOR SURFACE APPEARS WHILE DRIVING IN SPECIFIC LOCATION	Bulletin No.: 15-001/23
	Last Issued : 04/18/2023

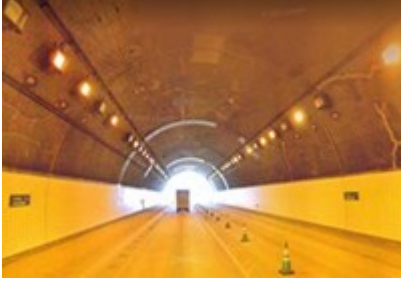
<p>2</p>	<p>Inside tunnels with an overall rounded shape</p>

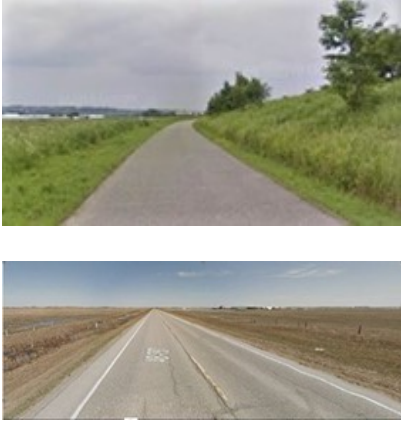
<p>3</p>	<p>Roads with no reflective objects around</p>

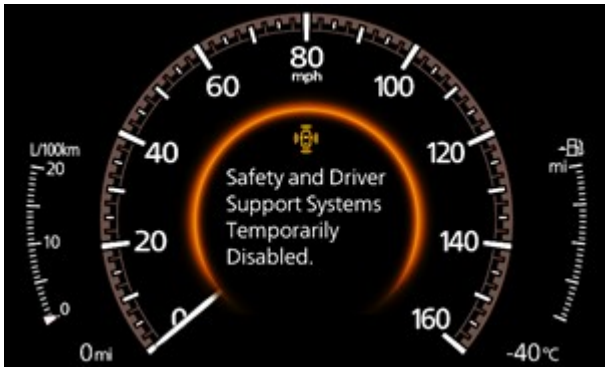
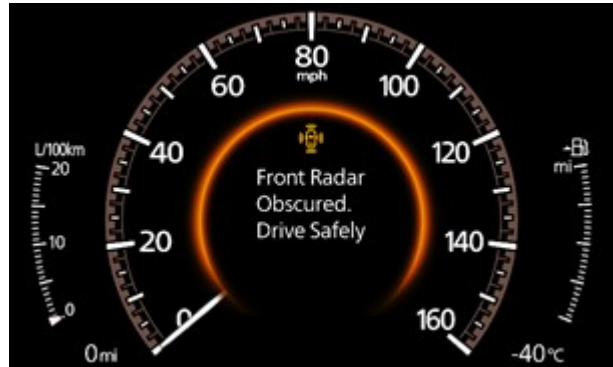
Warning message

Some vehicles may exhibit the warning messages "Safety and Driver Support Systems Temporarily Disabled" or "Front Radar Obscured. Drive Safely." displayed in the instrument cluster despite no dirt on the front radar sensor while driving in specific locations as follows:

This is caused by inappropriate decision logic of the control software in the front radar sensor. To eliminate this concern, the control software of the front radar sensor has been modified.

1. Verify the customer concern.
2. Replace the front radar sensor with a modified one according to the instructions on MGSS.
