# Technical Service Bulletin

## 51 Cracking noises in right rear roof area during steering thrust

51 23 27 2060145/5 April 27, 2023. Supersedes Technical Service Bulletin Group 51 number 21-22 dated May 11, 2021, for reasons listed below.

Model(s)	Year	VIN Range	Vehicle-Specific Equipment
Q8	2019 – 2021	All	Not Applicable
SQ8, and RS Q8	2020 – 2021

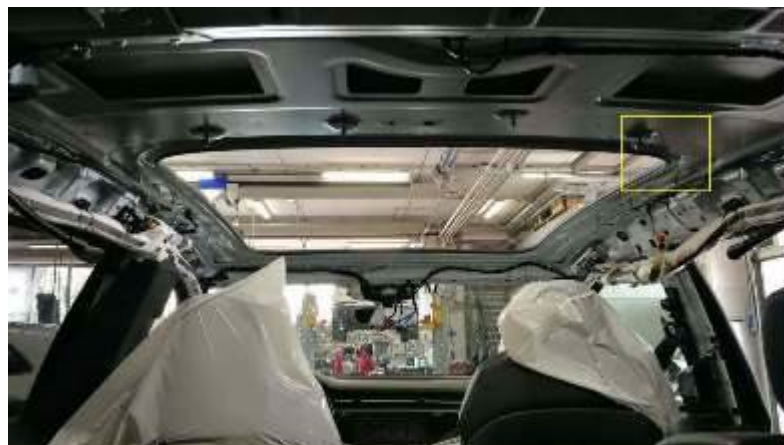
**Figure 1.** Right rear area of the sunroof opening to be reworked.

1. Remove the headliner and sliding sunroof assembly. Figure 1 shows the area to be reworked in the rear of the sunroof opening, beginning with the right rear.

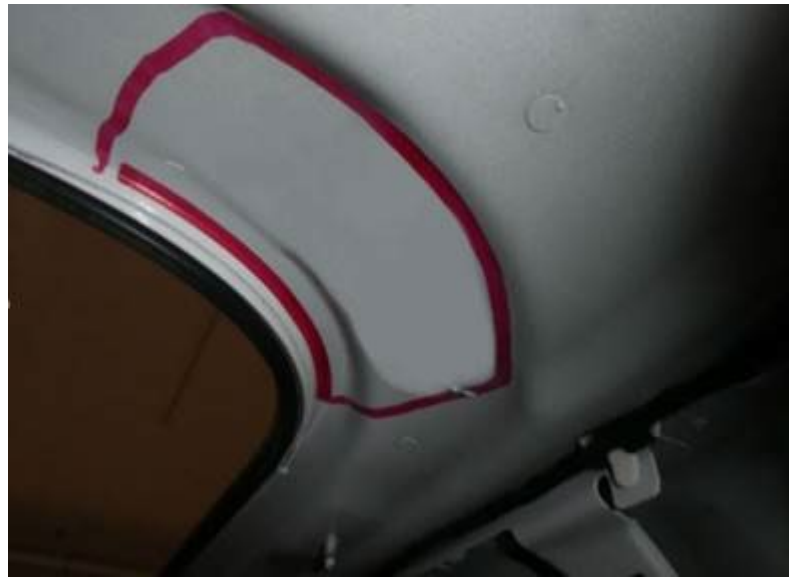
**Figure 2.** Area to be reworked.

2. Figure 2 shows a close-up view of the area to be reworked.

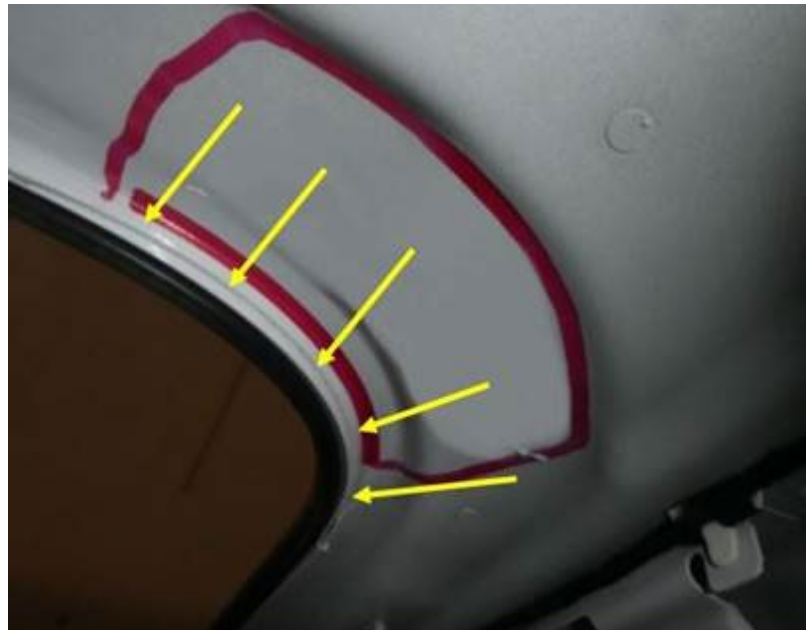
**Figure 3.** The yellow arrows show the joining seam of the outer roof sheet metal to be separated from the inner roof support.

3. The outer roof sheet metal is to be separated from the inner roof support (Figure 3).

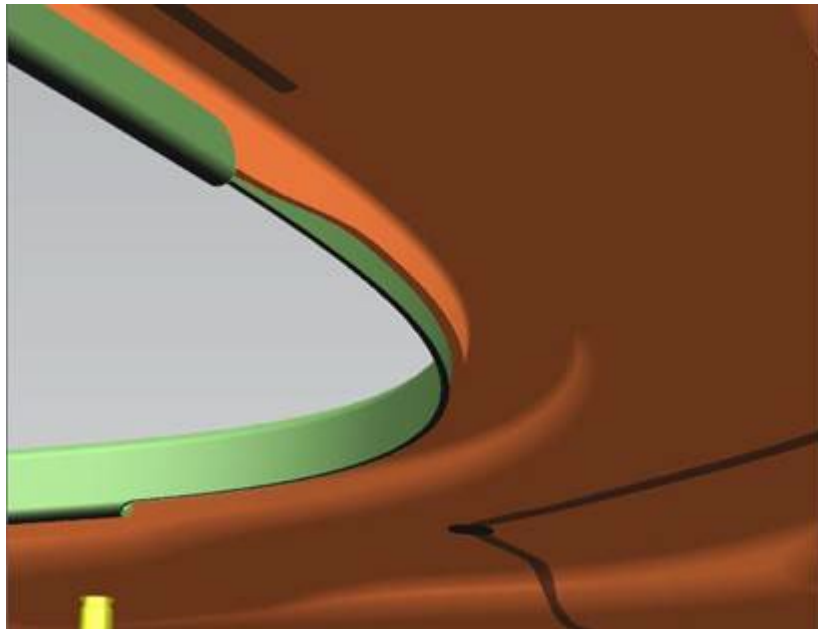
**Figure 4.** The section colored green is to be separated from the section colored orange in this drawing.

4. The drawing in Figure 4 shows the adjoining sheet metal that will be separated.

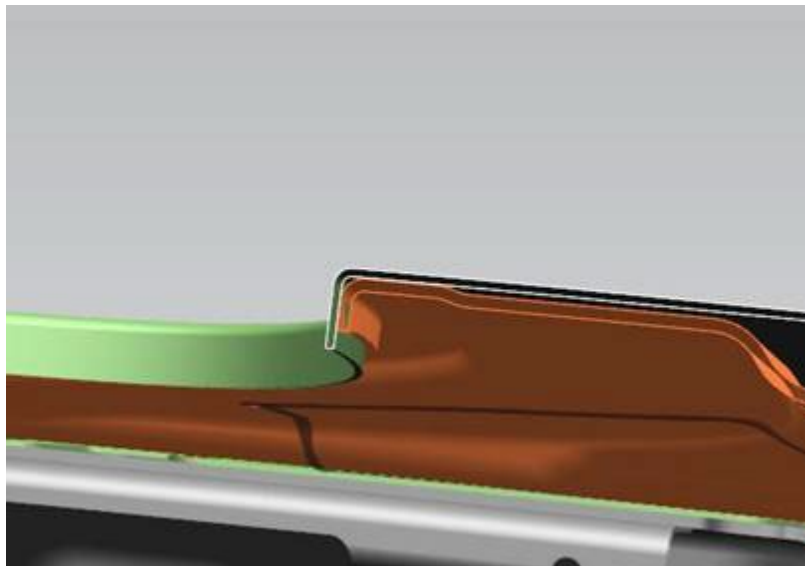
**Figure 5.** Cut-away view of the adjoining sheet metal that will be separated.

5. Figure 5 shows a cut-away view of the adjoining sheet metal that will be separated.

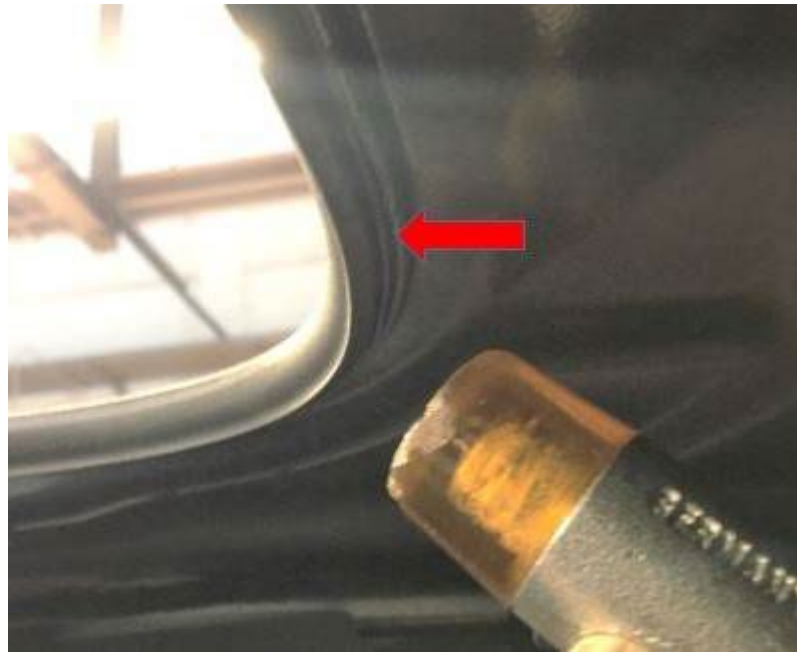
*Figure 6. Area of sheet metal to strike with a plastic mallet.*

7. Figure 6 shows the area of the roof sheet metal to strike with a plastic mallet. A light strike should suffice.

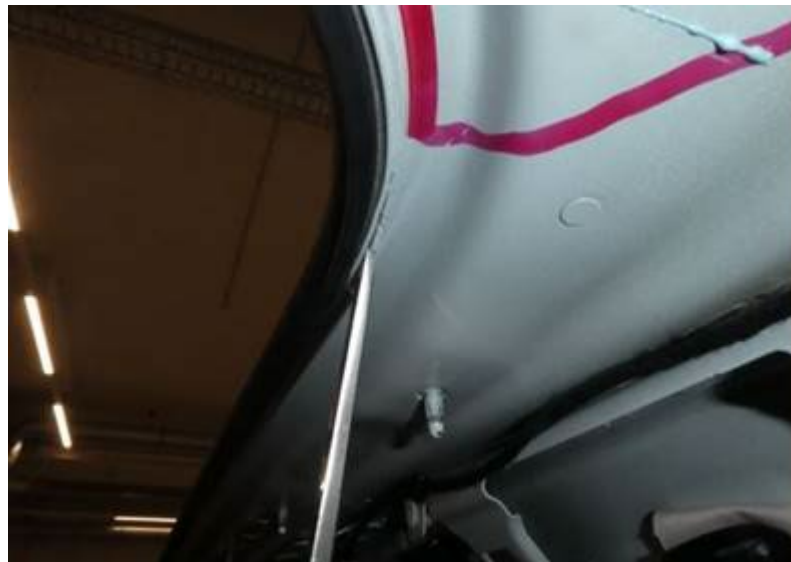
*Figure 7. Adhesive joint separated.*

8. If separation of the sheet metal proves to be more difficult than a light strike of a plastic mallet will produce use a small screwdriver or small chisel to break away the adhesive (Figure 7).

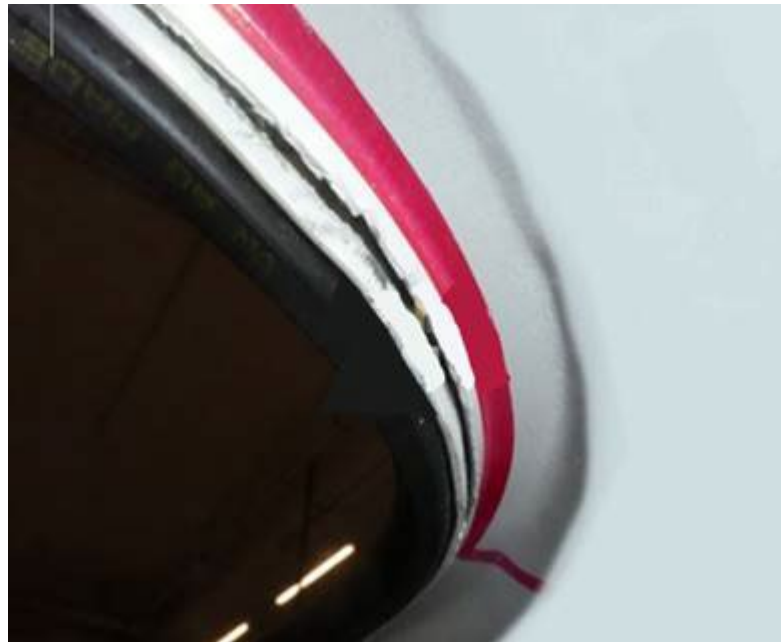
**Figure 8.** Create a gap of approximately 1mm.

9. Separate the adjoining sheet metal by approximately 1mm (Figure 8).

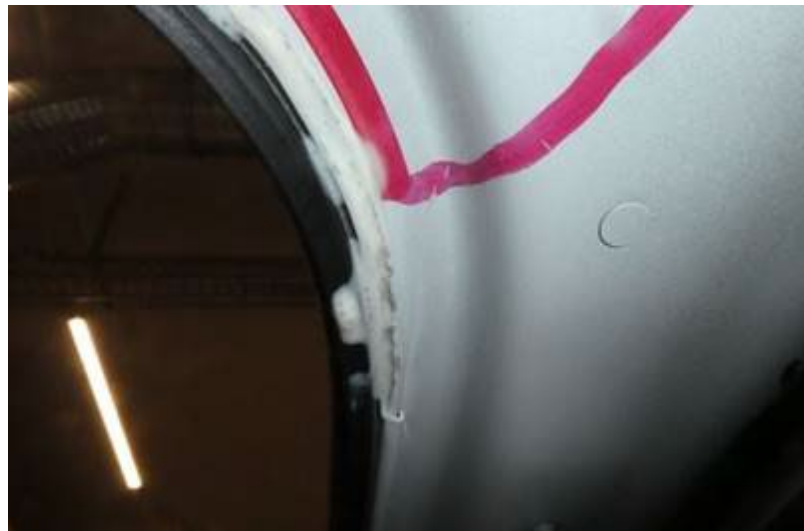
**Figure 9.** Gap created filled with Cavity Wax.

10. Through this gap fill the cavity with 08852 Cavity Wax Plus (Figure 9).
