#### 70 Noises from headliner/sunroof area

70 23 81 2044417/9 April 25, 2023. Supersedes Technical Service Bulletin Group 70 number 20-70 dated February 20, 2020, for reasons listed below.

| Model(s) | Year | VIN Range | Vehicle-Specific Equipment |
|---|---|---|---|
| A4 allroad, and Q7 | 2017 – 2018 | All | Not Applicable |

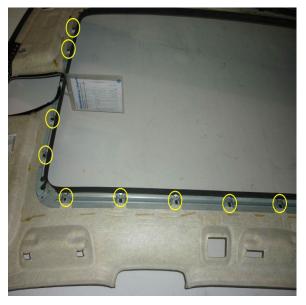
Figure 1. Location of the headliner to sunroof frame clips.

Remove the headliner. The clips shown in the illustration will need webbing adhesive tape (D 004350A2) (Figure 1).

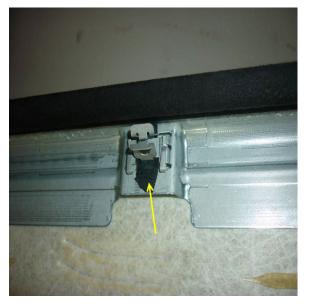
Figure 3. Clips reinstalled.

4. Reinstall the clips (Figure 3).

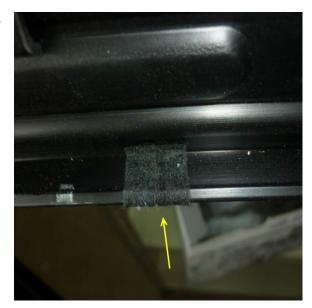
Figure 4. Application area on sunroof frame area of clip engagement.

Apply webbing adhesive tape to the sunroof frame lip at each clipping point (Figure 4).

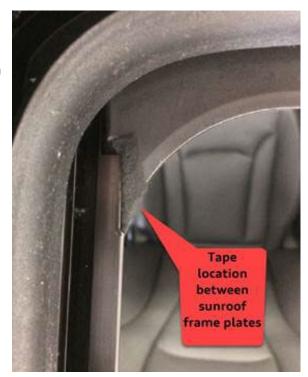
**Figure 6.** Webbing adhesive tape applied between the side and front sunroof frame plates.

7. Apply webbing adhesive tape between the sections of the sunroof frame plates on both the right and left sides as shown in the illustration (Figure 6).
