90 Audi virtual cockpit display has semi-circular marks on edges of display; B114815, U140500, B201C00, C121E00, U112300

90 23 23 2070020/1 April 17, 2023.

Model(s)	Year	VIN Range	Vehicle-Specific Equipment
Q3	2019 – 2023	-	Virtual Cockpit FPK2(+)
e-tron quattro	2019 2020 – 2023		
e-tron Sportback quattro	2020 – 2023		
A4, A4 allroad, S4, A5, A5 Cabriolet, A5 Sportback, S5, S5 Cabriolet, S5 Sportback, RS 5, RS 5 Sportback, A6, S6, A6 allroad, RS 6 Avant, A7, S7, RS 7, A8, S8, Q5, Q5 e quattro, Q5 Sportback, SQ5, SQ5 Sportback, Q7, SQ7, Q8, SQ8, and RS Q8	2021 – 2023	All	
A7 e quattro	2021 – 2022		
A8 e quattro	2021		
A3, S3, RS 3, and e-tron S quattro	2022 - 2023		
e-tron GT, and RS e-tron GT	2023

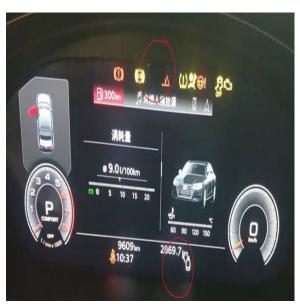
Hardware issue within the instrument cluster.

Figure 1: Circular spots along the top and bottom of display.

If the instrument cluster has the pictured semicircles present on the display, read out the production date of the instrument cluster using ODIS.

If the production date read out is **BEFORE** 01/01/2023, document this TSB in the claim notes and replace the instrument cluster.

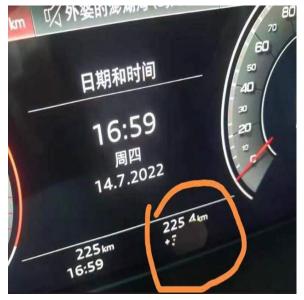
Figure 2: Circular spots in the trip odometer.
