Taycan: Vehicle Unlocks Itself Immediately After Locking with Comfort Access

Models	Model Year	Model Type	VIN Range	Vehicle-Specific Equipment
Taycan	2022	Y1A/ Y1B/ Y1C	N/A	N/A

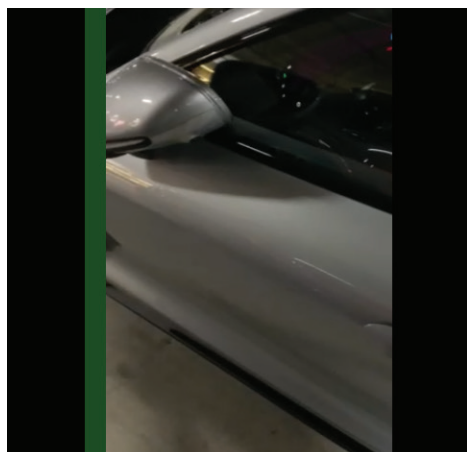
Customer states that the vehicle unlocks itself immediately after locking via the Comfort Access feature (see Figure 1). This is sometimes possible with both the front and rear door handles. Proper function of the system may be possible after at least one additional attempt to lock the vehicle.

Figure 1: Vehicle Locking After Unlocking

This issue may be caused by the incorrect positioning of the printed circuit board (PCB) inside the door handle body. An incorrect position of the PCB may cause the door handle to continuously transmit unlocking requests after locking the vehicle via the touch sensor on the outside of the handle.

The manufacturing process of inserting the PCB into the door handle has been optimized to increase the robustness of the Comfort Access function. Door handles with updated software for enhanced signal filtering are expected summer 2023.

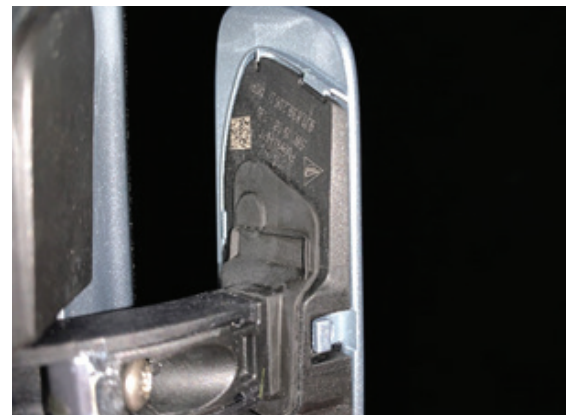
Figure 3: Manufacturing Stamp on Door Handle

4. Take pictures of the manufacturing stamps on the back of **all 4 door handles** (Figure 3) **and attach them to the PCSS job.**
5. Replace **only** the door handles which exhibit this condition as per *WM 571119 – Removing and installing door handle (front)* or *WM 581119 – Removing and installing door handle (rear)*.
