93 Update OBC software when replacing HV wiring harness for charging socket

93 23 03 2070110/1 April 25, 2023.

Model(s)	Year	VIN Range	Vehicle-Specific Equipment
e-tron quattro	2019	All	Not Applicable
e-tron Sportback quattro	2020

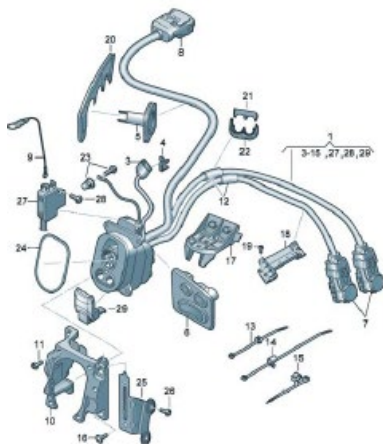
The High Voltage Wiring Harness for the charging socket UX4 or UX5 is replaced as part of any repair work (Figure 1).

Figure 1. High-voltage wiring harness for charging socket.

If the high-voltage wiring harness for the charging socket is replaced as listed in Table 1.2, an SVM code will need to be performed *and a replacement test plan performed*.
