Subject: MSP59 AS (AREA SURROUNDING) TESTER AIMING CONCERN	Campaign No.: MSP59
	Last Issued : 04/04/2023

(MSP) 59 AS (Area Surrounding) Tester Aiming

Model	Subject VIN range	Subject production date range
2023 CX-50	7MM VA****100509 – 107155	From February 15, 2022 through June 7, 2022

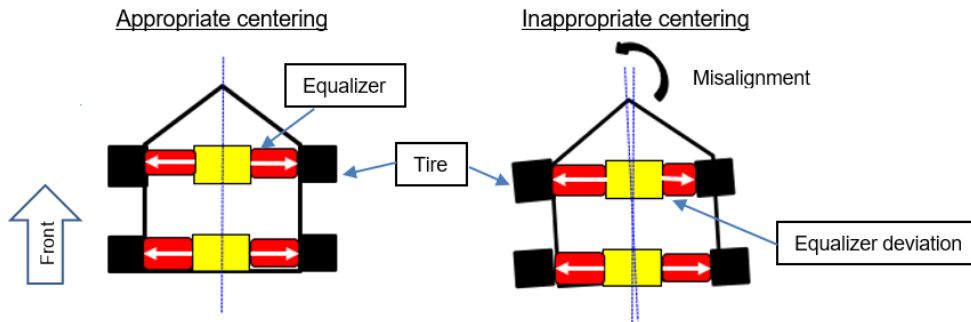
On the 360° View Monitor, the 360° or rear view may not be displayed correctly on the center display. The AS (area surrounding) the vehicle may be displayed as shifted from the actual position. Due to this problem, the vehicle may not be actually parked straight even it looks like straight on the screen. The aiming adjustment might not function appropriately as it could be damaged during routine maintenance. The 360° view monitor system (FSC/FR/VMC (includes rear view)) might not have been aligned appropriately during vehicle production

The repair is to perform the 360° view monitor system aiming for all 4 cameras (front camera, side cameras, rear mount camera) with M-MDS, using MDARS.
