Subject: MSP60 2023MY CX-50 DRIVER DOOR LOCK CONCERN	Campaign No.: MSP60
	Last Issued : 04/04/2023

(MSP) 60 Driver Door Key Lock Cylinder

**REPAIR PROCEDURE
Mazda Service Program MSP60**

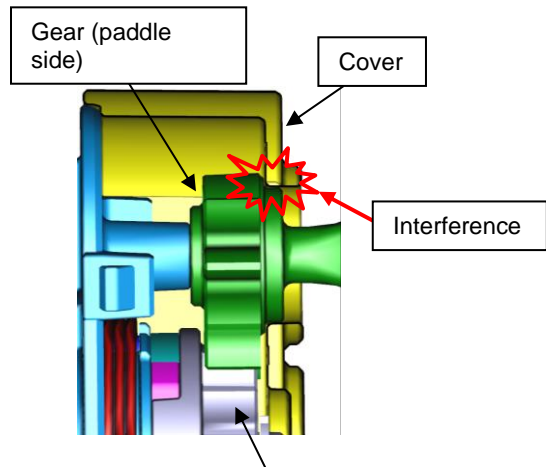
The driver’s door may be hard to unlock using the auxiliary key due to increased rotational resistance. All vehicles in the campaign will need to have the front driver door inspected to ensure proper mechanical key lock and unlock function. The expected failure rate is said to be less than 0.1% of the vehicle population.

Cycle the lock and unlock operations five (5) times using the main key in order to increase the clearance between the gear and cover (see photo above).
