Service Alert

Subject: CONNECTED VEHICLE SYMPTOM TROUBLESHOOTING	Service Alert No.: SA-009/23
	Last Issued : 04/25/2023

2019-2023 Mazda3
2020-2023 CX-30
2021-2023 CX-5
2021-2023 CX-9
2022-2023 MX-30
2023 CX-50
2024 CX-90

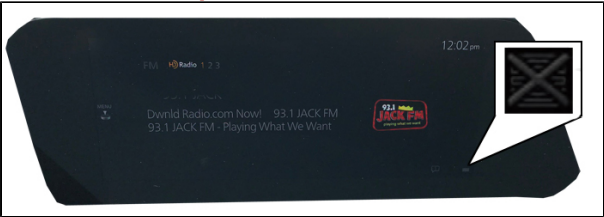
TCU in Deactivation Mode	<p style="text-align: center;">Reception Icon Shows "X"</p>

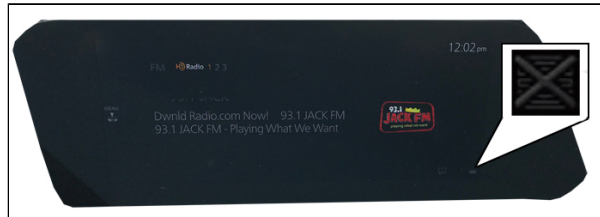
- If the reception icon shows "X", the vehicle is possibly in Deactivation Mode.

- Customer/Dealer can activate CV services anytime via MyMazda app (there just might be a slight delay in making the backend connection since it was temporarily deactivated).
- If the reception is weak, move the vehicle to a location where the reception is good to strong as shown in the table, then try to get the Authorization Code and/or operate the remote functions before proceeding to the Repair Procedure if there is still an issue.
- If the reception is good to strong, proceed to Connected Vehicle Troubleshooting below.

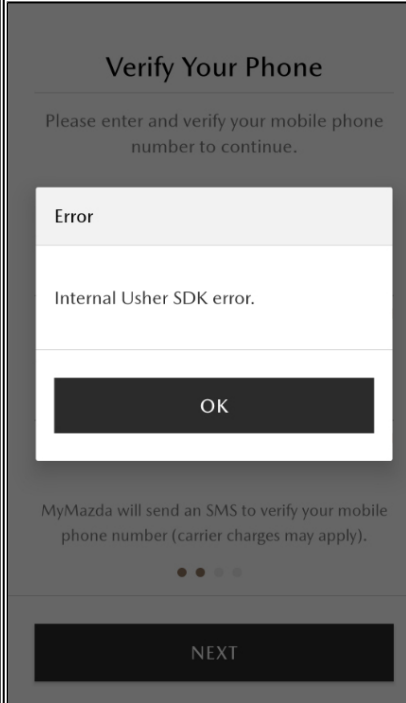
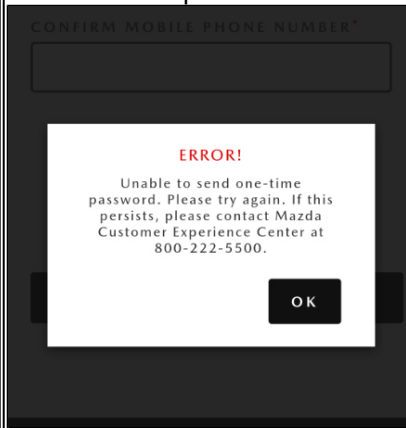
1

The customer is not able to create a MyMazda account. The customer receives the following error:

MyMazda App - Internal Usher SDK error.

MyMazda Website - ERROR! Unable to send one-time password.

Customer inadvertently texted "Stop" to 1-949 518-0058 (Twilio SMS for Mazda)

1. Text "Start" to 1-949 518-0058 (Twilio SMS for Mazda)
2. Retry to create a MyMazda account.

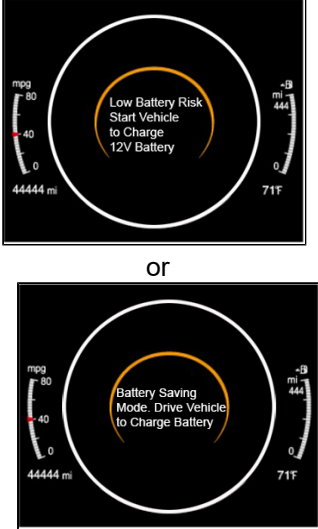
8	<p>2021 Mazda3, CX-30, CX-50, and MX-30 functions inoperative</p> <ul style="list-style-type: none"> • Vehicle Status Alert • Remote Engine Start / Stop • Remote Door Lock / Unlock • Remote Hazard Lights ON / OFF • Vehicle Finder (vehicle location mapping function is available) 	<p>Vehicle's electrical control area network (CAN) is in "Sleep Mode"</p>

<p>No dealer visit is required. Sleep Mode can be reset by starting the engine and idling or driving for 5 minutes or longer.</p> <p>Go to 09-010/22.</p>
9	<p>First remote control attempt fails, second attempt works fine.</p> <ul style="list-style-type: none"> • Engine Start / Stop • Door Lock / Unlock • Lights ON / OFF 	<p>Improper telematics communication unit (TCU) software.</p>	<p>Go to TSB 16-002/20.</p>
10	<p>Engine turns off when customer opens vehicle door.</p>	<p>Normal Operation</p>	<p>Advise that, for customer's safety and security, vehicle is designed to shut-off automatically when the vehicle door is opened.</p>
