Service Bulletin

Bulletin No.: 18-NA-307

Subject: Lack of Power, Reduce Power Displayed on Drivers Information Center (DIC), Rough Idle, Stabilitrak Light On, Malfunction Indicator Light (MIL) Illuminated - DTC P0014, P0365, P0366, P06A3, P16A1 and/or P016A2 Set

Brand:	Model:	Model Year:		VIN:		Engine:	Transmission:
		from	to	from	to		
Chevrolet	Colorado	2015	2022			LCV	
GMC	Canyon

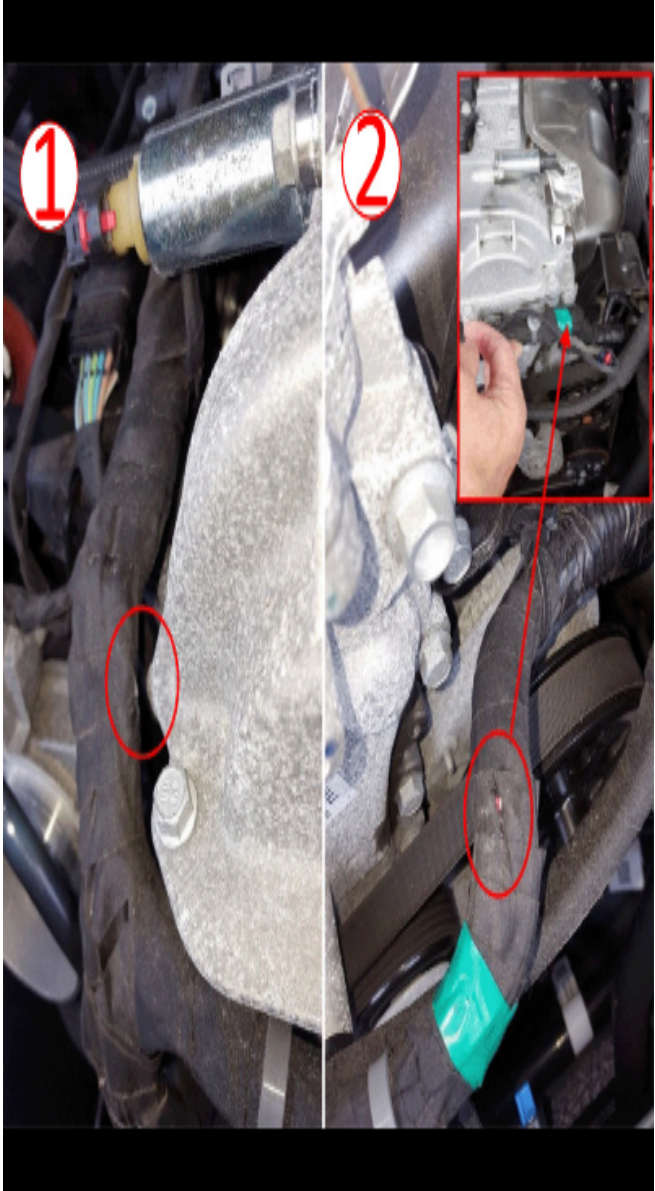
<p>5153274</p> <p>This may be caused by the engine wiring harness chaffing on the edge of the camshaft cover (1) and/or the cylinder head (2).</p>
<p>Correction</p>	<p>Note: Possible multiple effects or driver notifications may be experienced by one of the wires in the engine harness being chafed or cut in different circuits. Due to the cause of the condition, and the positions of the wires in the engine harness, it is unlikely that more than one circuit and/or fuse will be affected by the condition.</p> <ol style="list-style-type: none">1. Inspect the engine wiring harness conduit and wires for chaffing.2. Repair the wires. Refer to <i>Wiring Repairs in SI</i>.3. Using Woven Polyester Electrical Tape (PET), tape all the contact points of the engine harness ensuring that the tape is applied in a double layer extending along the engine harness past the camshaft cover or cylinder head.4. Utilizing tie straps, position the engine wiring harness away from the camshaft cover or cylinder head.
