Subject: <p style="text-align: center;">ENGINE NO START DUE TO LOW BATTERY VOLTAGE</p>	Service Alert No.: SA-023/23
	Last Issued : 04/14/2023

2017-2022 CX-5

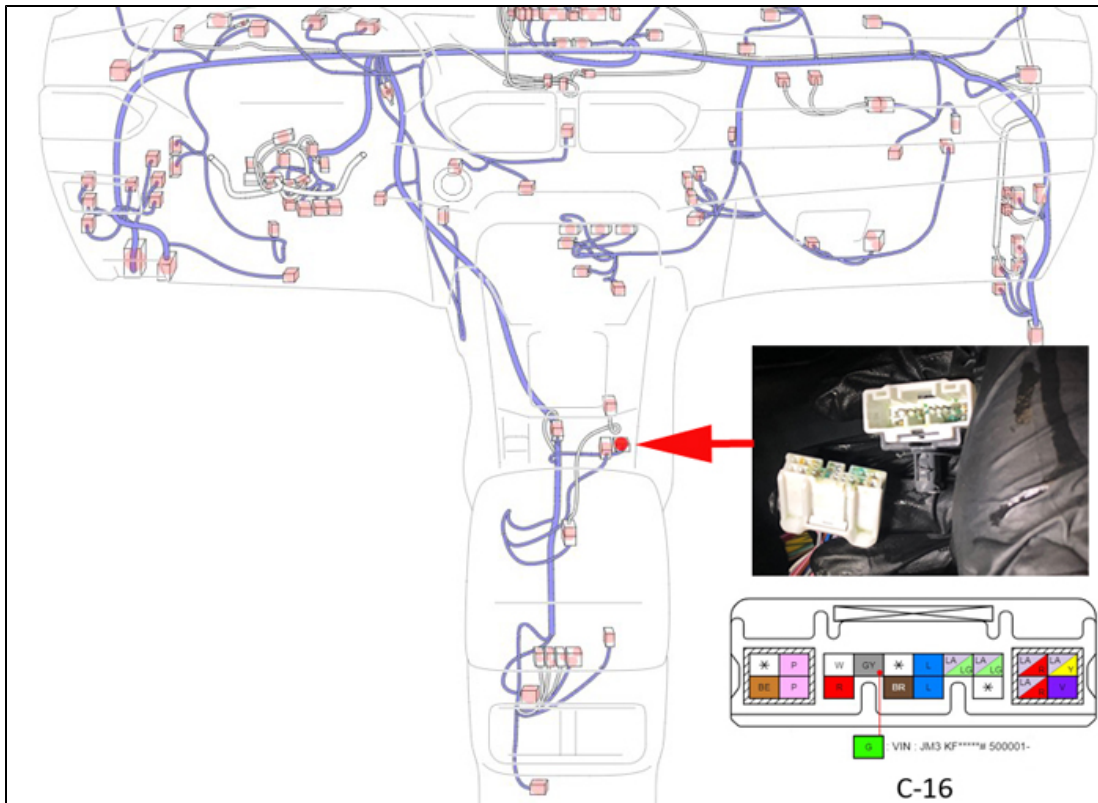
This may be caused by a liquid spill at the front cup holder.

1. Verify the customer concern.
2. Using M-MDS, document any DTC's stored.
3. Inspect the instrument panel harness connector C-16 for liquid spill corrosion.

Is corrosion found at connector C-16?

- **Yes** - Go to next step.
 - **No** - This service information does not apply. Continue with normal MGSS troubleshooting.
4. Repair/replace connector C-16 as needed.
 5. Wrap connector C-16 with electrical tape to protect it from liquid spills.
 6. Verify the repair.
