Subject: VARIOUS ELECTRICAL CONCERNS DUE TO CONNECTOR C-35 DAMAGE	Service Alert No.: SA-024/23
	Last Issued : 04/14/2023

2020 CX-9

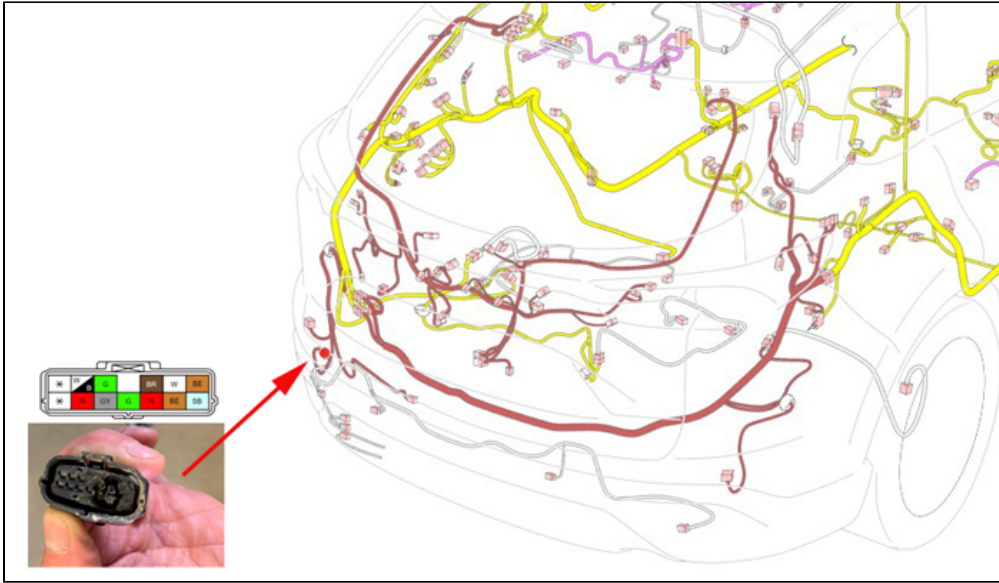
This may be caused from damage to the C-35 wiring connector C-35 (Rear No. 4 Harness / Short Cord).

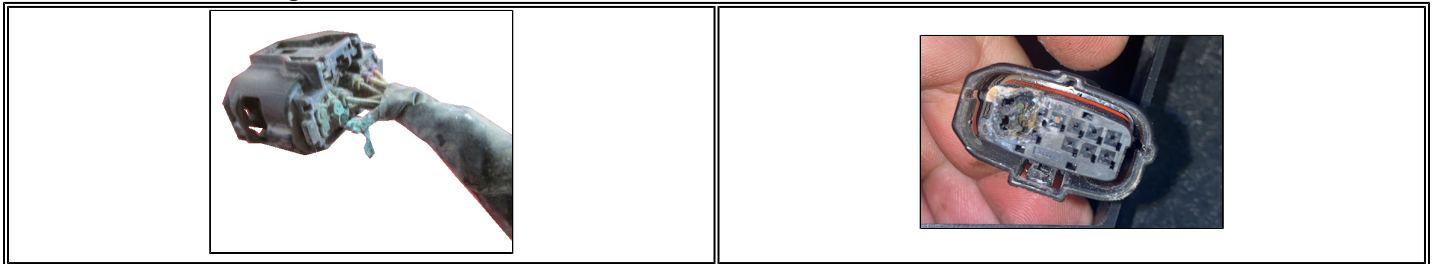
1. Verify the customer concern.
2. Inspect the wiring connector C-35.

Is the connector damaged/corroded/broken?

3. Repair/replace the rear the No. 4 harness / short cord as needed.
4. Use tape on connector C-35 to prevent future corrosion.
5. Verify the repair.
