Service Bulletin

Bulletin No.: 22-NA-079

Subject: Poor Engine Performance in Extremely Cold Weather Conditions for LSY Engines, Charge Air Cooler Icing, Malfunction Indicator Lamp (MIL) Illuminated with P0299

Brand:	Model:	Model Year:		VIN:		Engine:	Transmission:
		from	to	from	to		
Buick	Envision	2021	2023			LSY

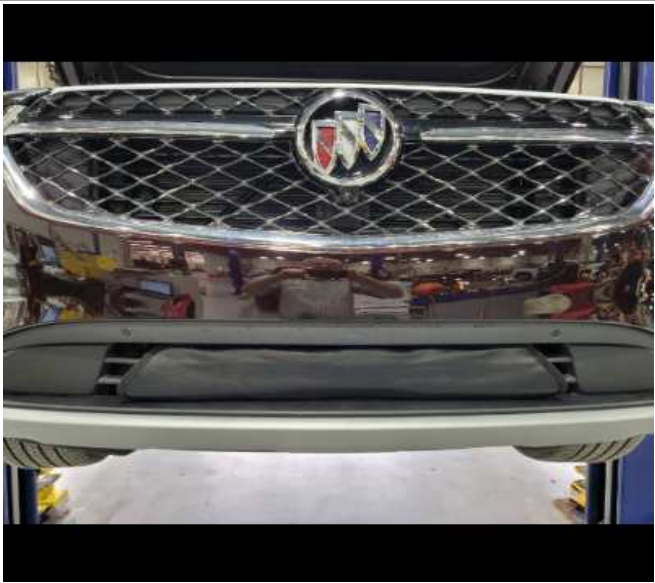
<p style="text-align: right; margin-top: 10px;">6029252</p>

Involved Region or Country	North America
Additional Options (RPOs)	Equipped with LSY Engines only
Condition	<p>Some customers may comment on one or more of the following conditions when driving in extremely cold weather conditions (-18°C or less / 0°F or less):</p> <ul style="list-style-type: none"> • Loss of power • Hesitation on acceleration • Stalling condition • Malfunction Indicator Lamp illuminated P0299
Cause	This condition may be caused by ice accumulation in the charge air cooler (CAC), restricting air flow.
Correction

A winter grille cover has been released to address this issue.
