**Location:** Powertrain / Electrical

**Topic:** Oil pressure warning

**Condition:** Intermittent

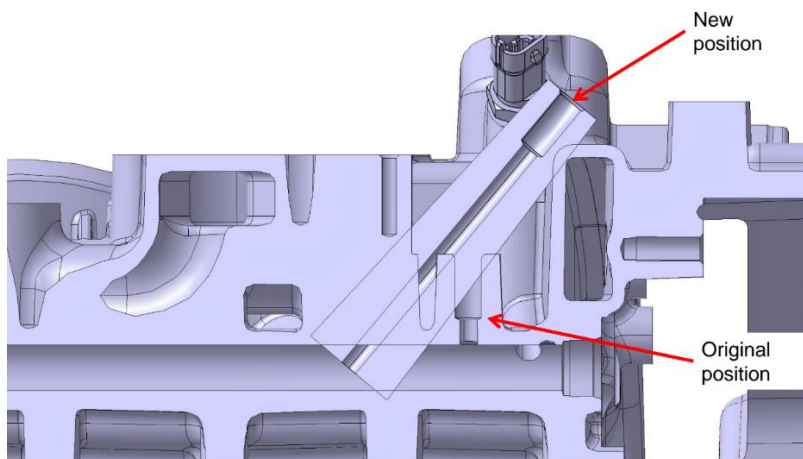
On early engine blocks, the oil pressure switch was positioned vertically within the casing. Due to the positioning, water may collect around the oil pressure switch electrical connection causing an intermittent oil pressure warning to illuminate.

Later engine blocks were re-designed so that the position of the oil pressure switch was clear of any water that could collect in the casing.
