Technical product information

Bentayga

EPB Warning light in DIP - Front door/s power latch system intermittent - DTC U112300 within Address 03 and Address 46

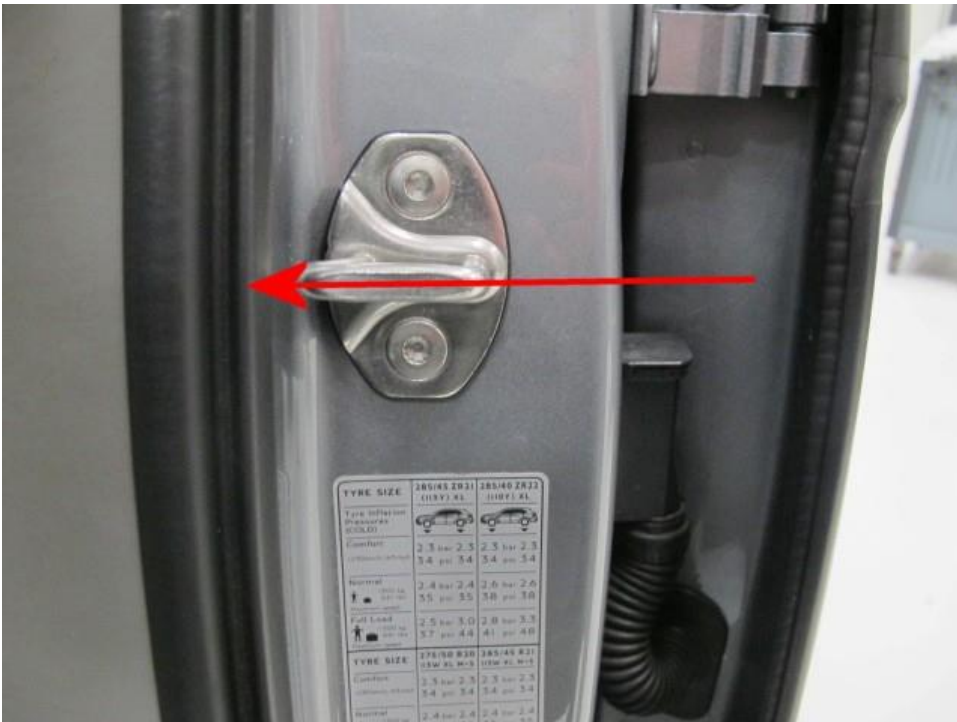
Figure 1

The micro switch signal of the door lock is not recognised or too briefly

A counter-pressure of the door is required to clearly recognise the signal

- 1) Check whether the striker runs into the centre of the rotary latch of the door lock and correct it if necessary - Refer to Rep.Gr 57 - Door striker
- To remove and fit

In addition, adjust the striker as far as possible (at least 0.5 mm) further inwards (Figure 1)
