# SERVICE BULLETIN

**Communication #:** I-23-04

## SUBJECT: 2023 SCOUT OXYGEN SENSOR CONNECTOR

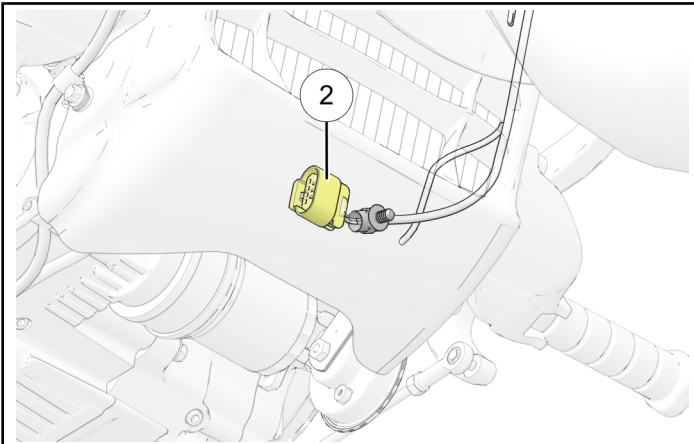
Indian Motorcycle has determined that some Model Year 2023 Scout motorcycles may not have the front oxygen (O2) sensor properly connected. If the O2 sensor becomes disconnected a Check Engine Light will illuminate.

1. Park motorcycle on a flat surface, fully extend side stand, and make sure vehicle is stable.
2. Turn key to OFF position and remove key.
3. Locate the Front Oxygen Sensor Connector ②.

4. Perform a push/click/pull test to make sure the Front Oxygen Sensor Connector is fully connected.

Verify electrical connector is properly seated and locked in place by listening for an audible “click” when pressing into place. Pull gently on electrical connector to make sure a proper connection has been made.
