Service Bulletin

Bulletin No.: 23-NA-025

Subject: Engine Control Module Software Anomalies with MIL Illuminated and DTC P060C Set

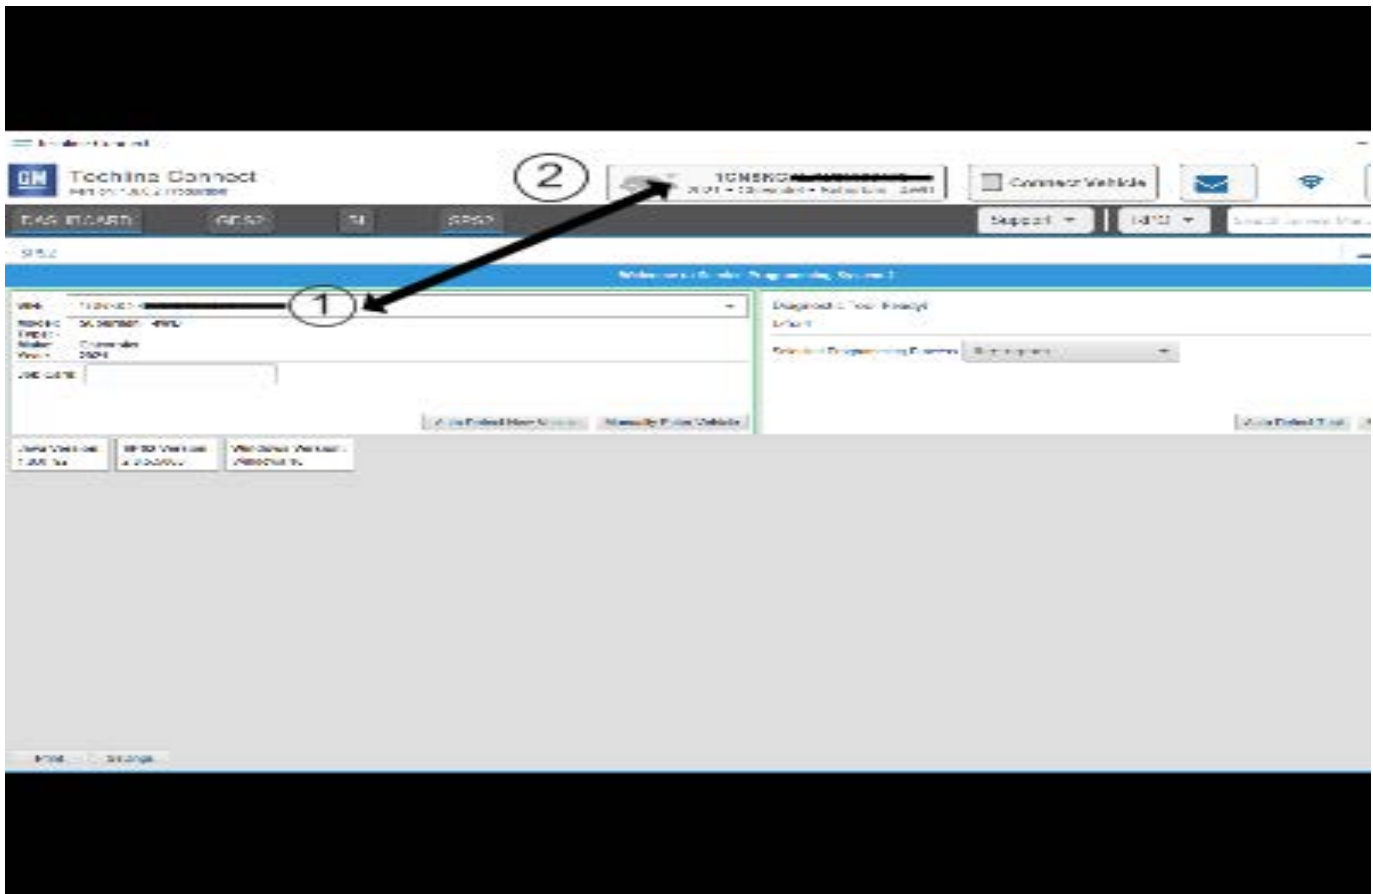
5743643

Caution: Be sure the VIN selected in the drop down menu (1) is the same as the vehicle connected (2) before beginning programming.

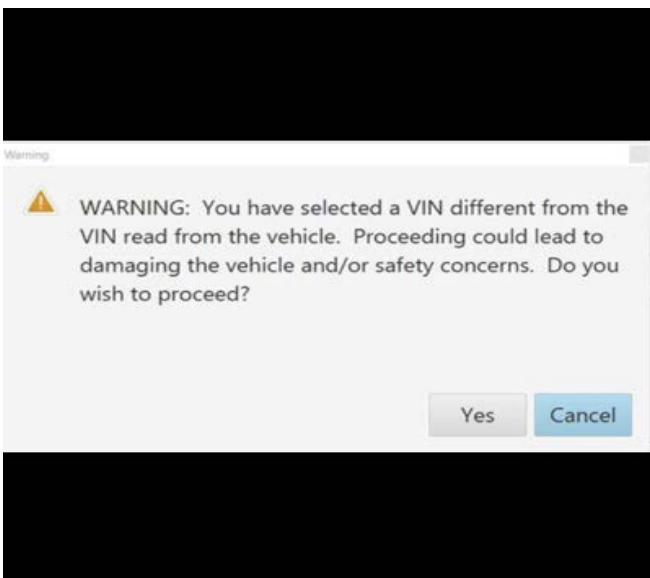
5877000

Important: If the vehicle VIN DOES NOT match, the message below will be shown

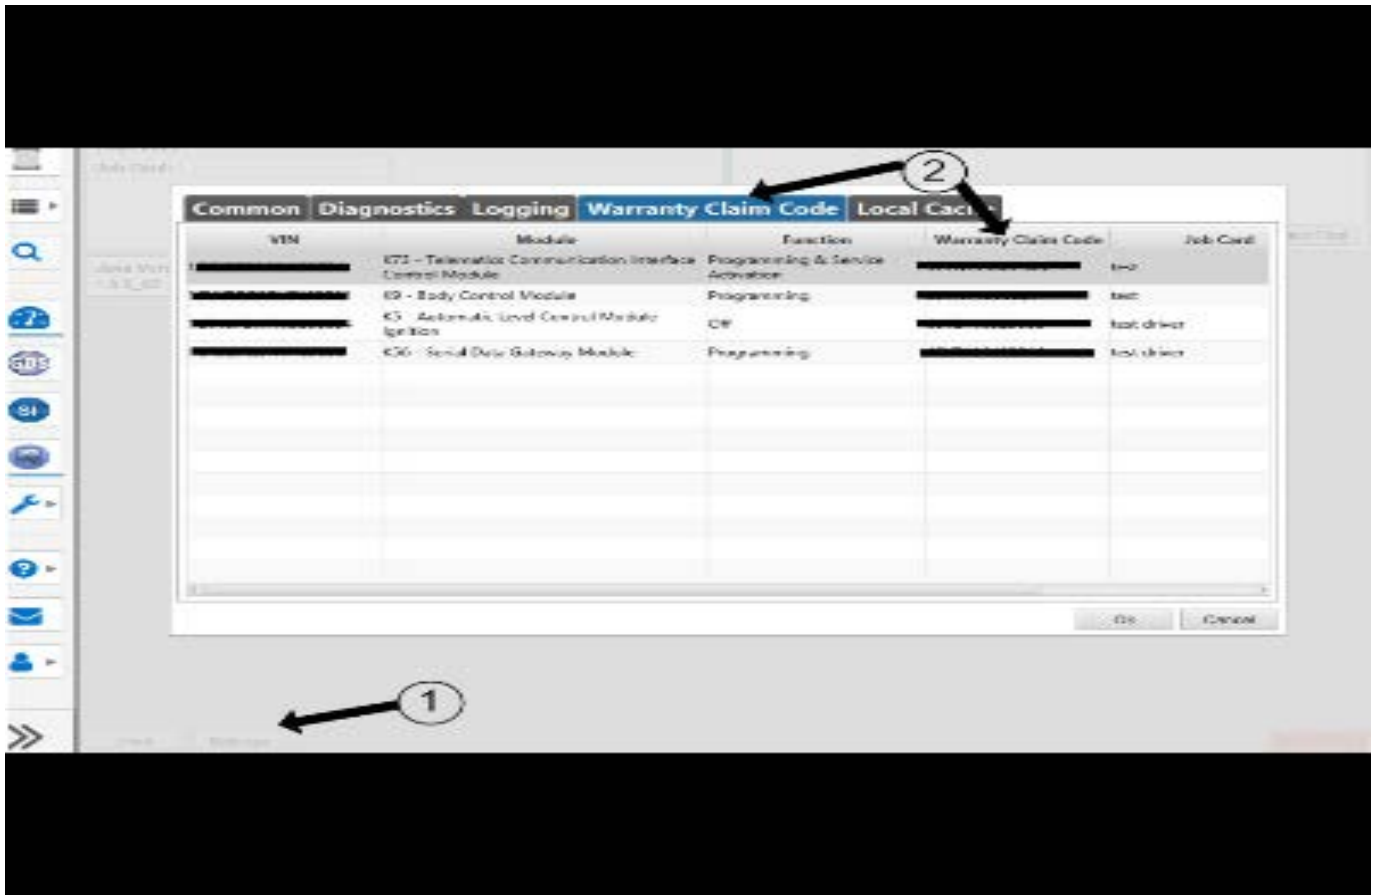
6125774

If the Warranty Claim Code was not recorded on the Job Card, the code can be retrieved in the SPS2 system as follows:

1. Open TLC on the computer used to program the vehicle.
2. Select and start SPS2.
3. Select Settings (1).
4. Select the Warranty Claim Code tab (2).
