# Service Bulletin

Bulletin No.: 23-NA-030

**Subject: Airbag Light On - DTCs B0014 / B0021 SIAB Harness Connector Contacting Seat Back Foam (New Seat Back Foam), Intermittent Service Airbag System Message, DTCs B0014, B0021**

Brand:	Model:	Model Year:		Build Date:		Engine:	Transmission:
		from	to	from	to		
Chevrolet	Bolt EV	2022	2023	—	December 16, 2022	All	All
	Bolt EUV

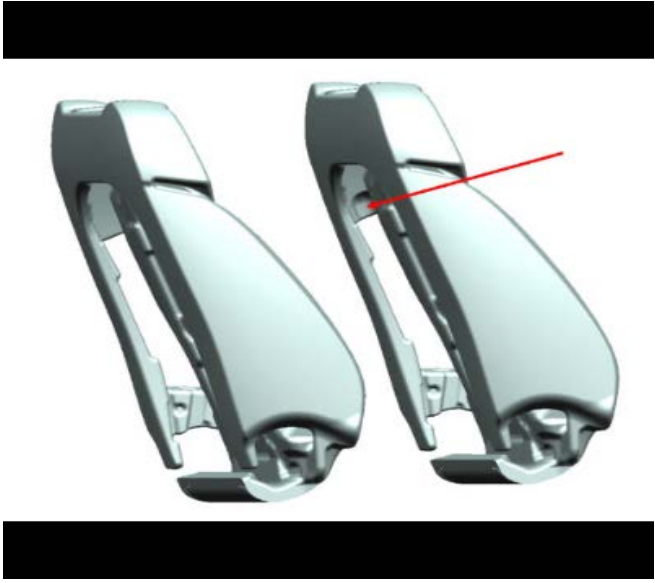
<b>Involved Region or Country</b>	North America, Middle East, Brazil, GM Korea Company
<b>Condition</b>	Some customers may comment on a "Service Restraint System" message displayed in the driver information center (DIC). Some customers may also comment on the Airbag Readiness Light coming on intermittently after start up. Technicians may also find DTC B0014 or B0021 with symptom byte :04 or :0D active or in history.
<b>Cause</b>	The condition may be caused by an interference between the front seat back pad assembly and the side impact airbag wiring harness assembly.
<b>Correction</b>	<div style="text-align: center;">

</div> <p style="text-align: right;">6325181</p> <p>Replace the front seat back pad assembly with a new part number that includes a larger clearance zone for the side impact airbag wiring harness assembly.</p>

If you encounter a vehicle with the above concern, replace the front seat back pad. Refer to *Front Seat Back Cover and Pad Replacement* in SI.
