GLOBAL SAFETY FIELD INVESTIGATIONS  
DCS6557  
URGENT - DISTRIBUTE IMMEDIATELY

Subject: N222375791-03 - Customer Satisfaction Program  
Park Assist Retrofit  
Population Update

## N222375791 Park Assist Retrofit

**Revision:** 03

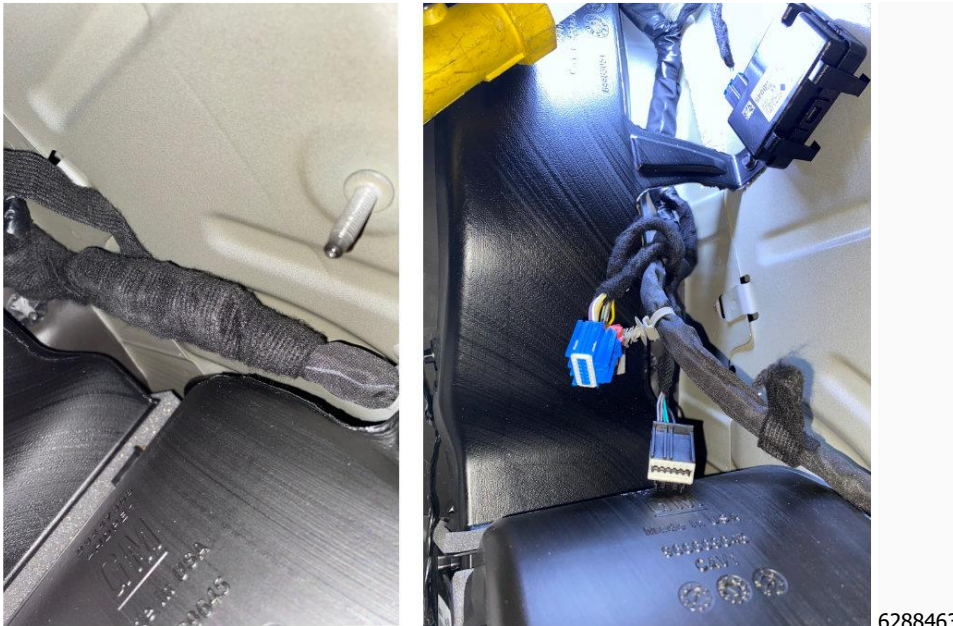
Camaro

**Note:** The wiring harness for the Parking Assist Control Module may be wrapped around an adjacent wiring harness as shown above. Remove the attaching tape by unwrapping. Do NOT cut the tape as it could damage the wiring harness.

1. Install the new Parking Assist Control Module. Refer to *Parking Assist Control Module Replacement* in SI.

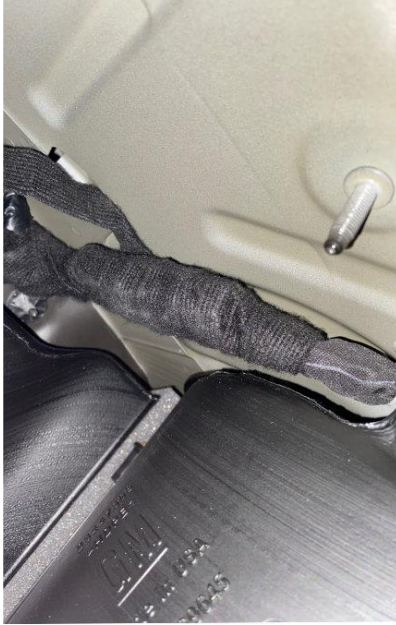
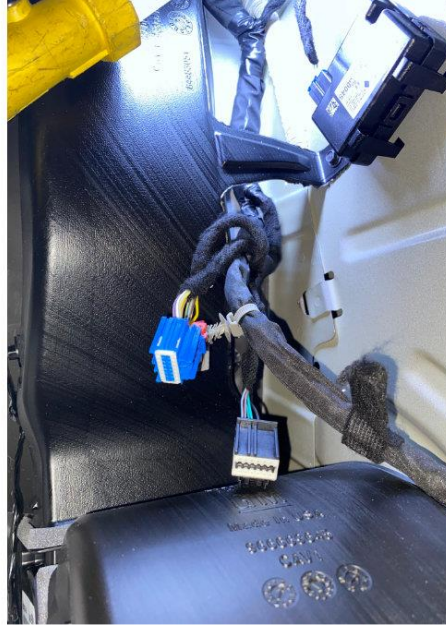
## XT4 with UD5 without UGN, UVZ, or UKL

**Note:** The wiring harness for the Parking Assist Control Module may be wrapped around an adjacent wiring harness as shown above. Remove the attaching tape by unwrapping. Do NOT cut the tape as it could damage the wiring harness.

1. Install the new Parking Assist Control Module. Refer to *Parking Assist Control Module Replacement* in SI.

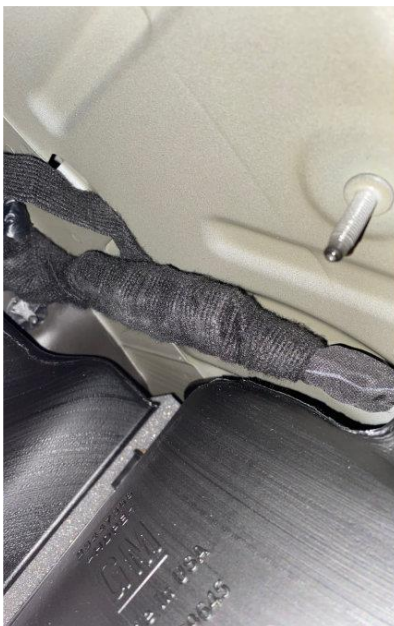
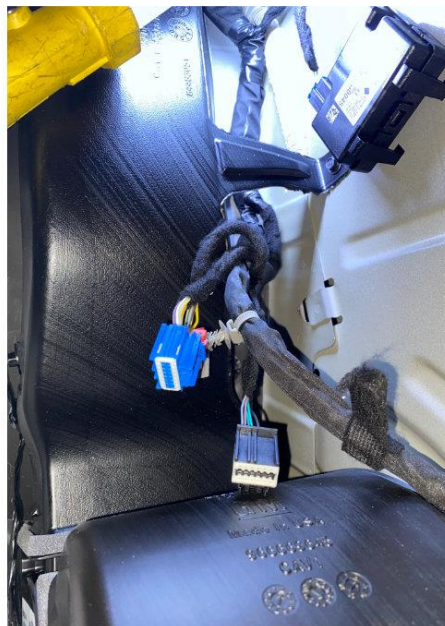
**Enclave with UGN, UVZ, or UKL**

**Note:** The wiring harness for the Parking Assist Control Module may be wrapped around an adjacent wiring harness as shown above. Remove the attaching tape by unwrapping. Do NOT cut the tape as it could damage the wiring harness.

1. Install the new Parking Assist Control Module. Refer to *Parking Assist Control Module Replacement* in SI.

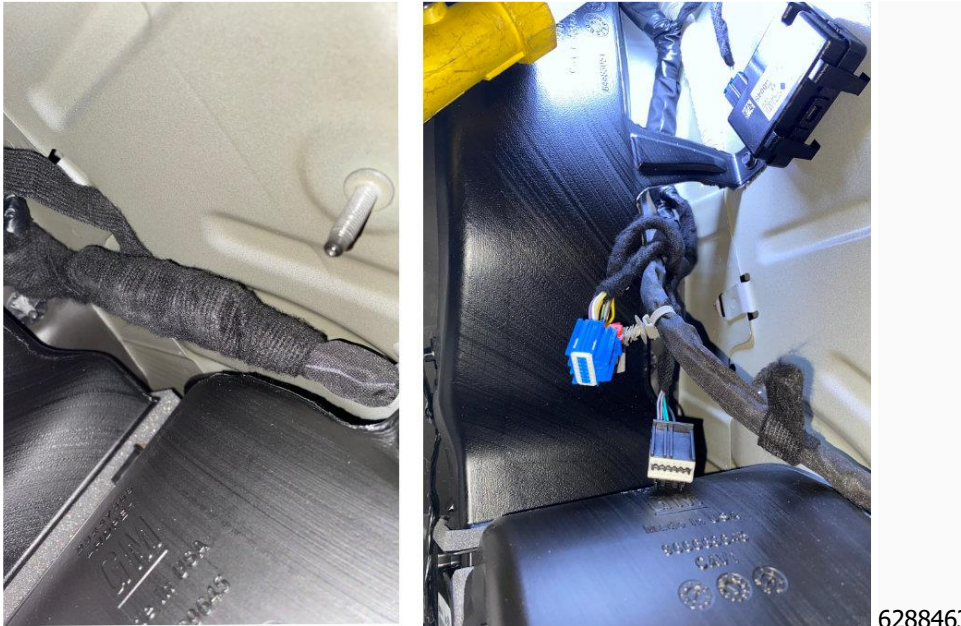
Enclave without UGN, UVZ, or UKL

**Note:** The wiring harness for the Parking Assist Control Module may be wrapped around an adjacent wiring harness as shown above. Remove the attaching tape by unwrapping. Do NOT cut the tape as it could damage the wiring harness.

1. Install the new Parking Assist Control Module. Refer to *Parking Assist Control Module Replacement* in SI.

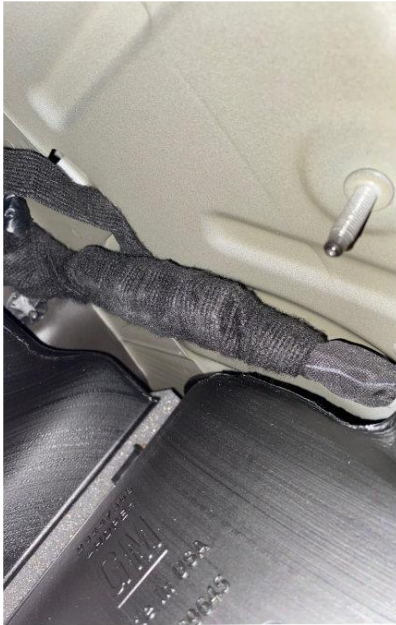
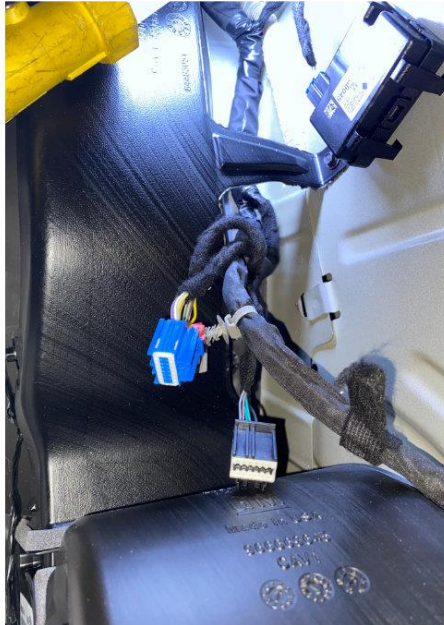
### Acadia with UGN, UVZ, or UKL

**Note:** The wiring harness for the Parking Assist Control Module may be wrapped around an adjacent wiring harness as shown above. Remove the attaching tape by unwrapping. Do NOT cut the tape as it could damage the wiring harness.

1. Install the new Parking Assist Control Module. Refer to *Parking Assist Control Module Replacement* in SI.

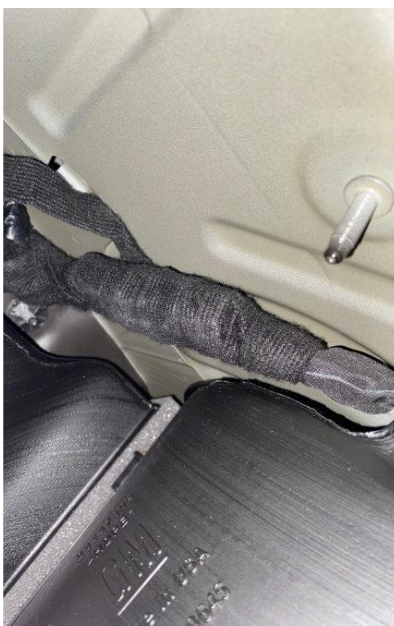
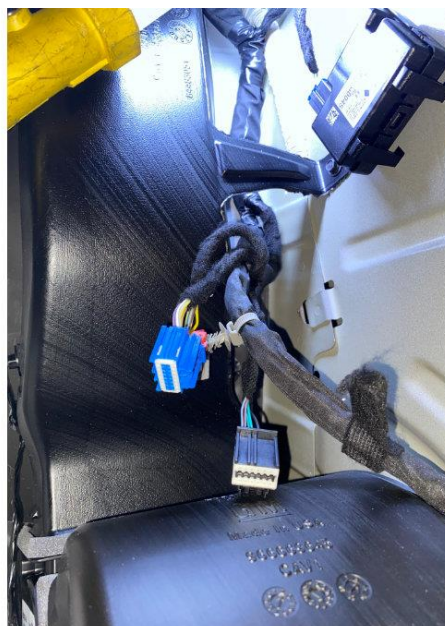
## Blazer with UGN, UVZ, or UKL

**Note:** The wiring harness for the Parking Assist Control Module may be wrapped around an adjacent wiring harness as shown above. Remove the attaching tape by unwrapping. Do NOT cut the tape as it could damage the wiring harness.

1. Install the new Parking Assist Control Module. Refer to *Parking Assist Control Module Replacement* in SI.
