Seal, Weather Trim Strip on Rear Doors Detaching

Topic number	LI72.12-P-076175
Version	1
Function group	72.12 - Rear door
Date	4/12/23
Validity	MODEL 206 206.0 FIN/VIN "F" up to manufacturing date: 18 January 2023 206.0 FIN/VIN "R" up to manufacturing date: 23 February 2023
Reason for change	Old part number: A2066906700 28 outer right B-pillar trim molding New part number: A2066906800 28 outer right B-pillar trim molding

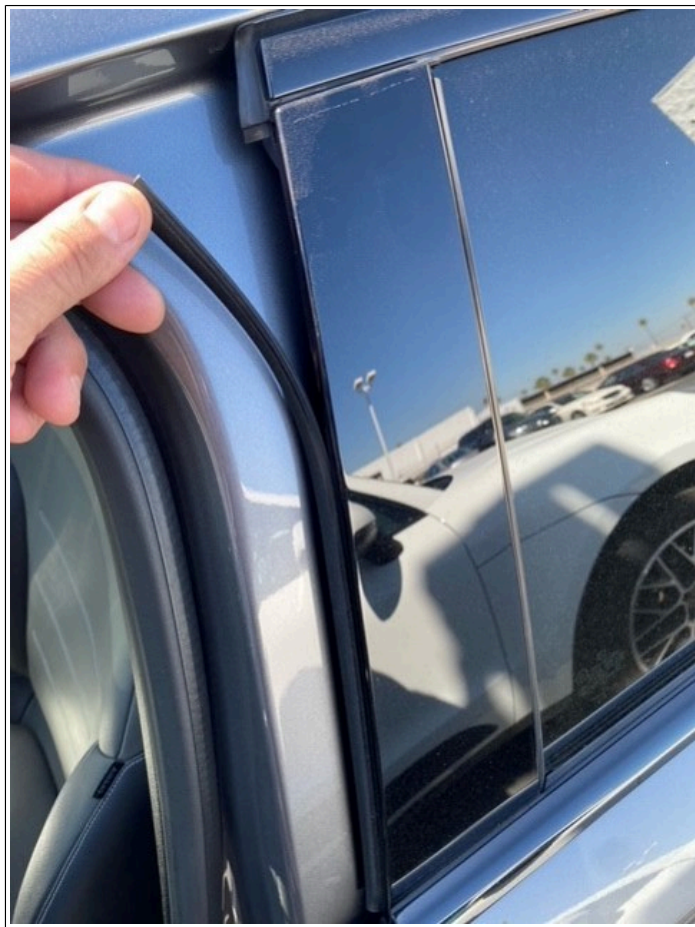
Seal, weather trim strip on rear doors detaching in upper area, see picture 1.

Attachments	
File	Description
Bild 1.jpg	Weather Trim Strip Detaching

Production deviation at supplier of weather trim strip.

Replace weather trim strip through optimized parts.
